Characteristics of Prototype Silicon Sensors for Run2b

K. Hara and Y. Takei

University of Tsukuba, Tsukuba, Ibaraki, Japan

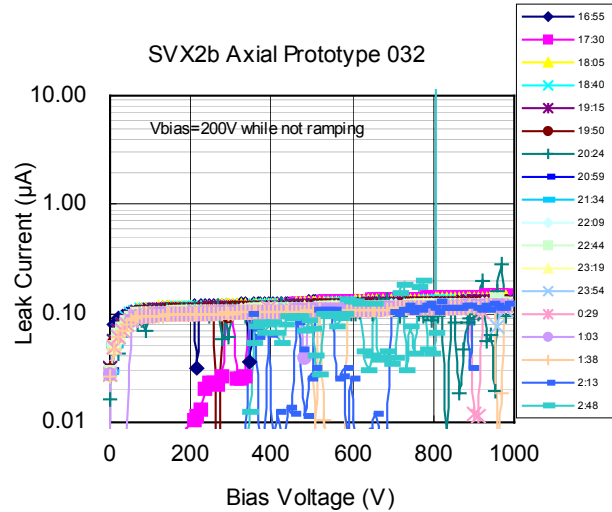
Fig. 2b Faulty I-V stability of sensor #032 (axial).

We measured the stability of I-V curves for sampled sensors including those which showed micro-discharges. The I-V measurement was repeated 20-30 times (10 times for some sensors). Between the I-V measurements, the sensors are biased to 200V and kept for 30 minutes. Figure 2a overlays I-V curves measured for a typical sensor, stereo #045. The curves are consistent and stable although the initial I-V tends to be somewhat different. This may be attributed to that the sensor surface condition is being stabilized in time between. Among the 6 axial sensors we measured, 5 sensors showed similar to the figure. One sensor (axial #032: see Fig. 2b) showed initially good I-V. The I-V curves became in chaos after 7hr and the sensor drew a large current at 800V after 10 hr. We investigated the cause with an IR camera and found a deep trace of discharge on the bias -ring. We suspect that a discharge occurred between the bias-ring (which is DC connected to a p+ implant underneath) and the substrate probably due to some defect in the wafer. The I-V of this sensor has no recovered indicating existence of permanent junction breakdown.

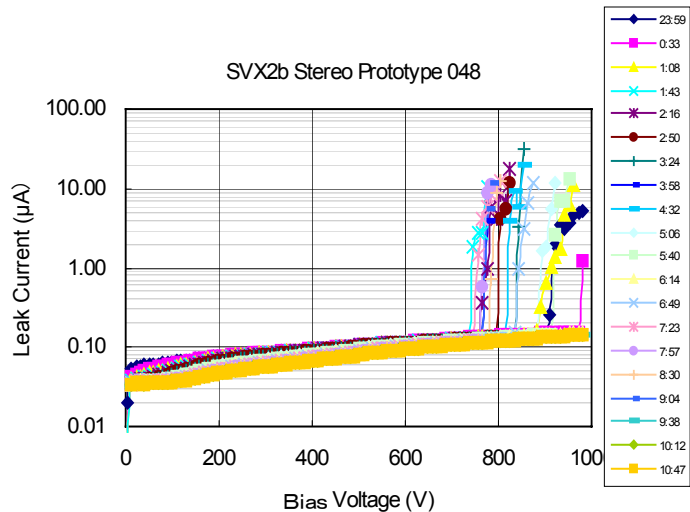
Fig. 2d I-V stability of sensor #048 (stereo).

showed micro-discharge in the initial I-V, improves the I-V curve gradually. The micro-discharge onset voltage of Sensor #048 (see Fig. 2d) was fluctuating around 800V. The I-V became flat to 1000V in the last three measurements. Note that the initial I-V is already better than the one shown in Fig. 1b because the sensor was biased for other test before this stability test was made. Other sensors showed stable I-V curves up to 1000V.

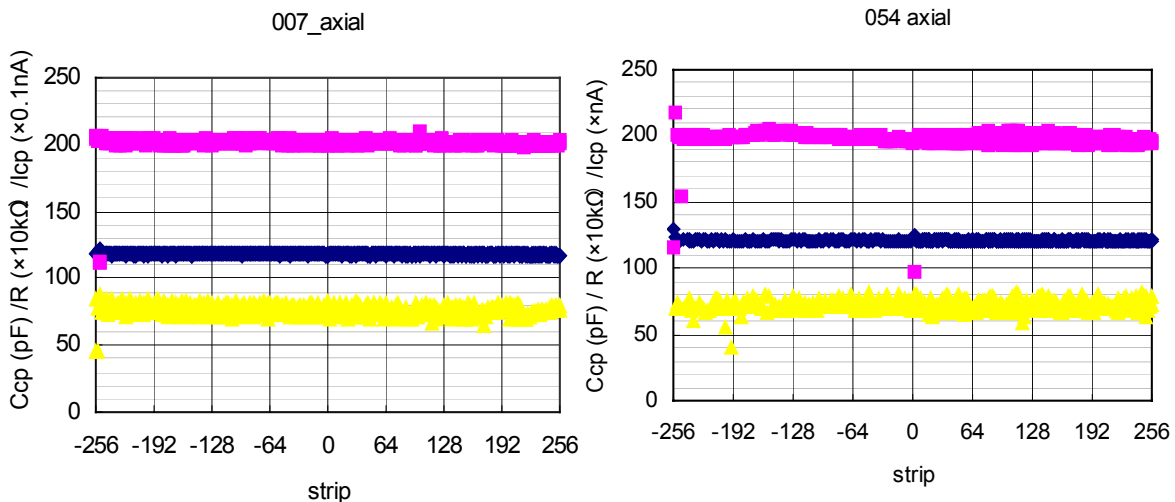
Some example results are shown in Fig.4b, where we found some defective strips. In total, AC scan is made for 18 axial sensors and 18 stereo sensors. The comparison of dead channels reported by HPK is described later. Among the defective strips, there are a couple of readout strips which showed irregular values and we found clear breaks in the implant strips. An example of such AC scans is given in Fig. 4c, where RD24 (-24 in the plot) has smaller R and Ccp values.

Fig. 4b AC scan result for (left) axial #007 and (right) axial #054

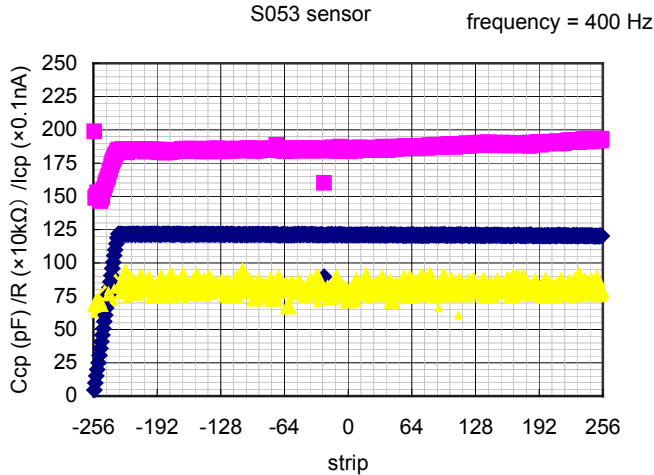
Fig. 4d AC scan result for stereo #053. One strip (-24) shows smaller R and Ccp values. This was not recognized by HPK, but a clear break was found in implant strip.

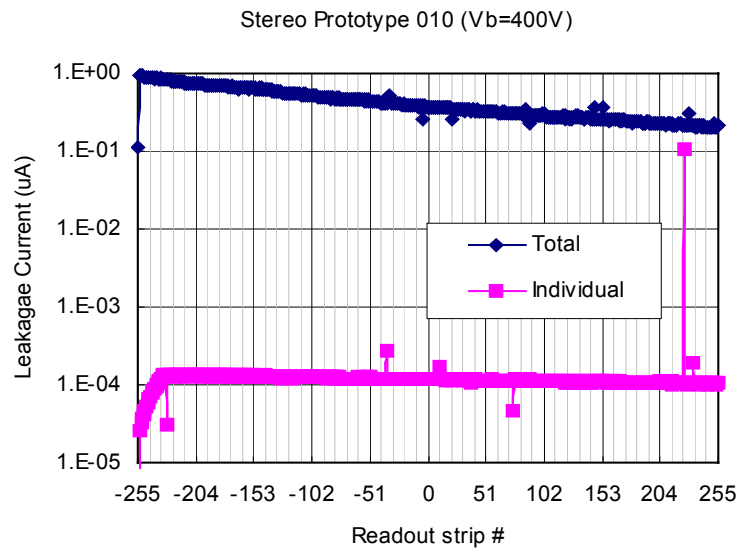
The DC scan was made only for leaky sensors. An example result is given in Fig. 5, where the total leakage current evolution during the measurement is also plotted for stereo sensor #010. The bias is set to 400 V, above the micro-discharge onset voltage. The total leakage decreases as the measurement proceeds, as we have seen in I-V stability test. Since the total leakage current is about 0.1-0.2 μA for good sensors, the excess of this sensor is initially about 1 μA and finally 0.1 μA .

Fig. 5 DC scan (stereo #010) measured at 400V

The excess is totally explained by a single leaky strip, U225. This strip is classified as dead (Leaky) by HPK. Another leaky Sensor (stereo #048) has also single leaky intermediate strip, which is identified by HPK.

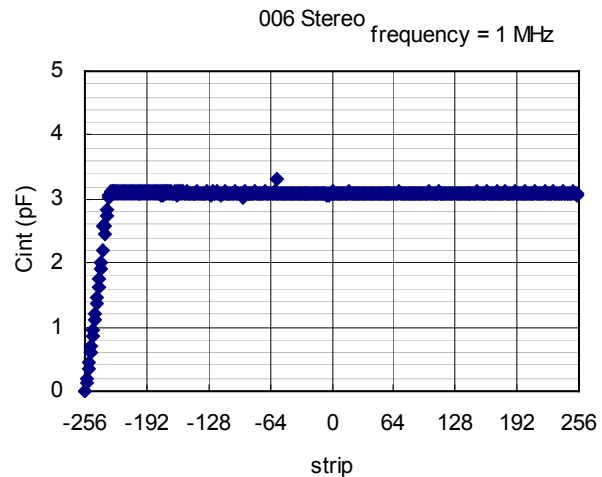
Fig. 7b Interstrip capacitance: Sensor 006 (Stereo) with an irregular value.

sensors showed irregular values, one pairs for each. An example is given in Fig. 7b. In fact the irregularity for this sensor did not present at the first measurement, but it appeared. In the ime between the probe scratched out the AC pad by mis-operation. Similar thing may have happened to other sensor, and we suspect these irregularities are created during the testing at Tsukuba. There is no other problem found for these strips by visual inspection under microscope.

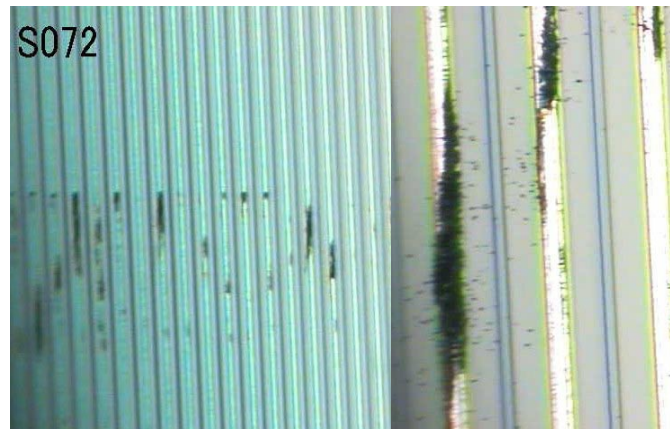
The axial sensors are in general clean and we did not recognize major flaws. As described in Section 2, the stereo sensors, on the contrary, showed visible problems. Figure 8a is a typical picture found for about 2/3 of Class B stereo sensors. Enlarged view shows that the scratches are on the very surface of Al traces. These scratches are created when the wafers were taken out manually from the process line, which is not expected to happen in the production. We checked if there is any correlation between faulty strips and the scratches, but there seems no correlation.

Fig. 8a Example of scratches observed for stereo sensors.
(Right) Enlarged view.

From these observations, we conclude that these sensors are good in electrical performance. We classify them as Class B (do not use them, unless delivery becomes a major problem for completion of the project) .

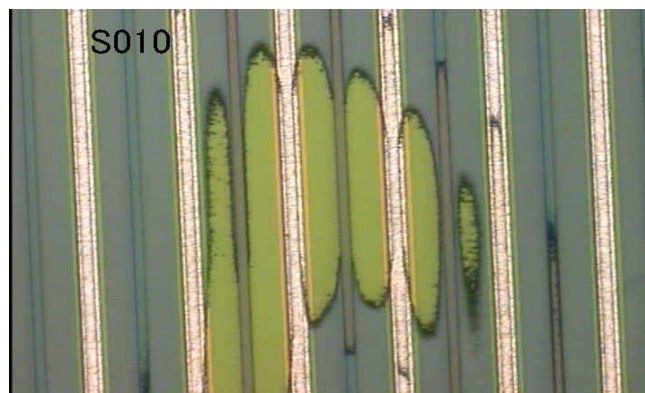
A yellow spot shown in Fig. 8b is found only for Stereo 010 sensor. Stereo 010 Sensor showed micro-discharge, but the contributing strip is not the one in this yellow spot.

Fig. 8b Yellow spot found for Stereo 010 Sensor.

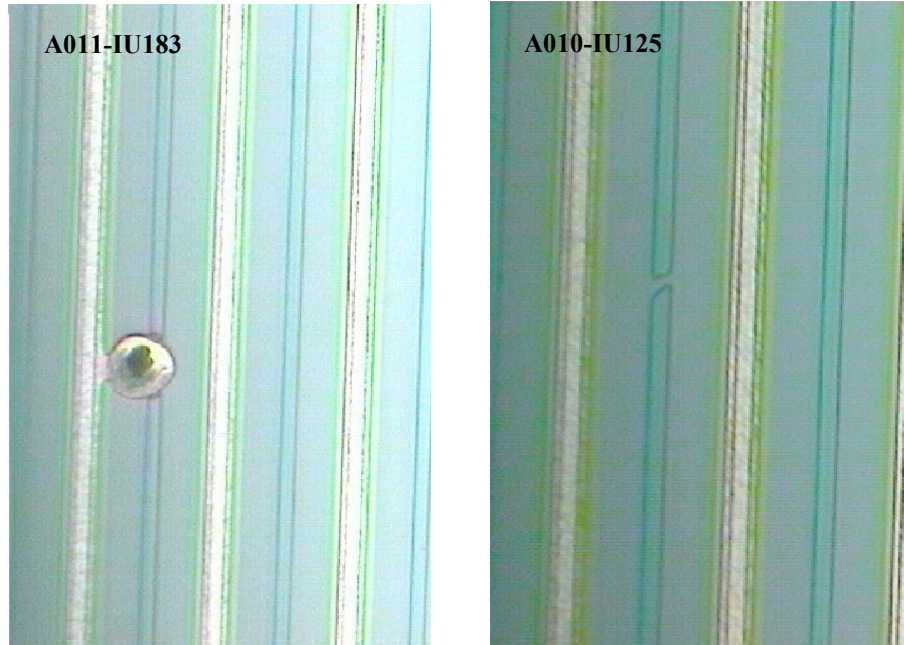
Fig. 8c Example of implant opens. (Left) Axial 011 Sensor and (Right) Axial 010 Sensor

Figure 8c shows examples of implant opens. Typical implant opens are similar to the one found for Axial 010 Sensor (intermediate strip U125).

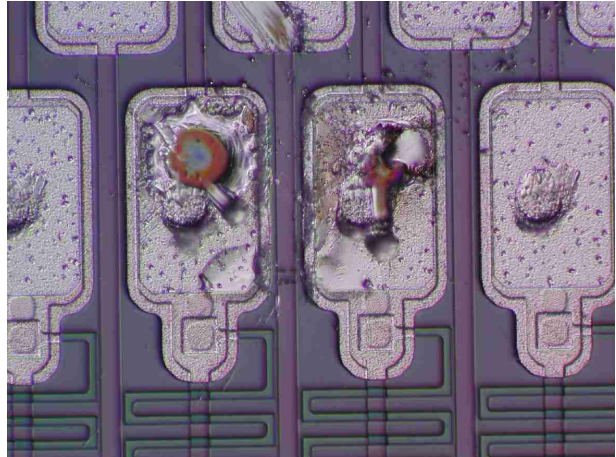
After all, two strips (Sensor 7, RD251 and RD 252) are new and not fully understood. This sensor (and some other sensors) is sent back to HPK to investigate the problem. According to HPK investigation, small discharge should have happened. The photograph taken by HPK is shown in Fig. 8d. The DC pads of these strips are colored and black discharge traces are visible bridging the two pads.

Fig. 8d Photograph around DC pads of RD251 and RD252. Two black traces are visible bridging the two DC pads. (Photo taken by HPK)
