Characteristics of Prototype Silicon Sensors for Run2b (I)

K. Hara and Y. Takei

University of Tsukuba, Tsukuba, Ibaraki, Japan

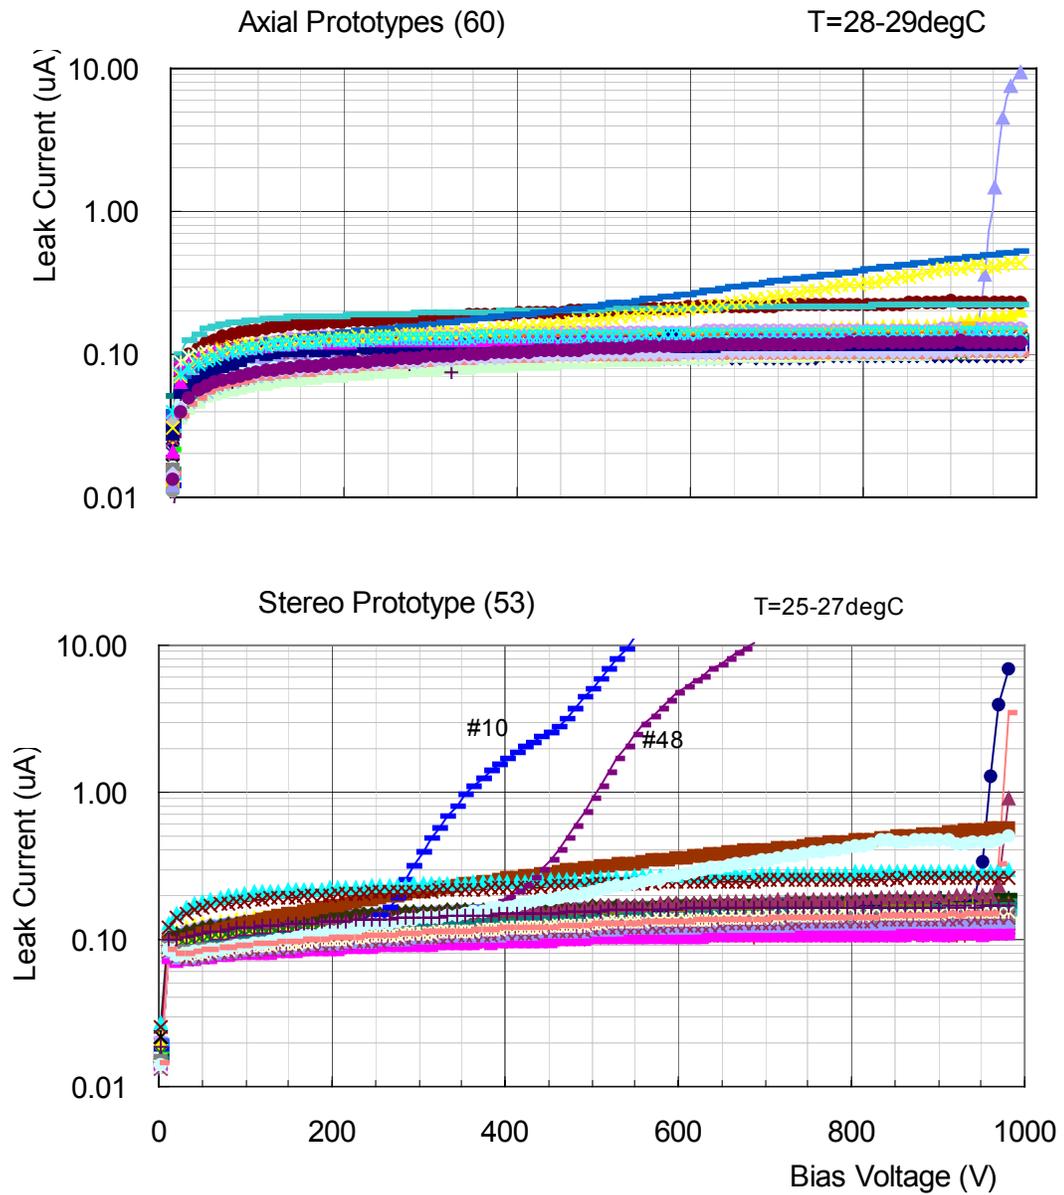
Figures 1a and 1b show I-V curves of 60 axial and 53 stereo sensors. Most of the sensors do not show significant micro-discharge up to 1000V we measured. Exceptions are #010 and #048 stereo sensors, which showed micro-discharge at voltages above 300V-450V. As described in 3.5, single leaky strip contributes to the micro-discharge for both sensors. The I-V curve of these sensors became moderate by keeping the bias, as described in 3.2. We set our leakage current requirement to be less than 2 μA at 500V. This limit ensures that no single readout strip has a significant leakage current exceeding $\sim 1\mu\text{A}$. Actually, ISL sensors, which were double sided, had an average leakage current roughly one order more than the present sensors, and substantial

All the sensors fulfill our specification (S010 stereo is just on the boundary). Since the fraction of such micro-discharge sensors is small, two out of 113, we should avoid using such sensors as far as the production delivery goes as scheduled.

Fig. 1a (top) I-V curves of 60 axial sensors.

Fig. 1b (above) I-V curves of 53 stereo sensors.

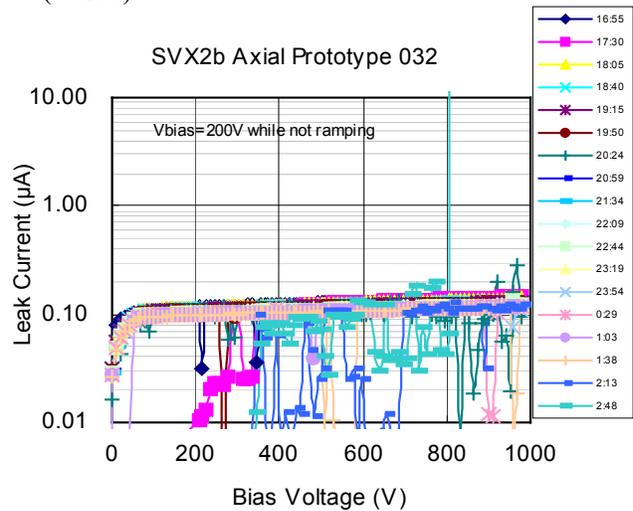
One sensor (axial A032: see Fig. 2b) showed initially good I-V. The I-V curves became in chaos after 7hr and the sensor drew a large current at 800V after 10 hr. We investigated the cause with an IR camera and found a deep trace of discharge on the bias ring. We suspect that a discharge occurred between the bias-ring (which is DC connected to a p+ implant underneath) and the substrate probably via defect in the wafer. The I-V of this sensor has not recovered indicating creation of permanent junction breakdown.

Fig. 2b Faulty I-V stability of sensor A032 (axial).

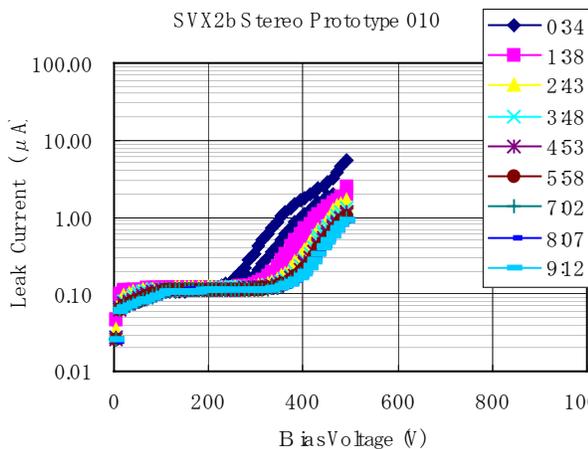
For stereo sensors, we measured I-V stability for 10 sensors. Sensor S010 (see Fig. 2c), which showed micro-discharge in the

Fig. 2c I-V stability of sensor S010 (stereo).

initial I-V, improved the I-V curve gradually. The micro-discharge onset voltage of Sensor #048 (see Fig. 2d) was fluctuating around 800V. The I-V became flat to 1000V in the last three measurements. Note that the initial I-V is already better than the one shown in Fig. 1b because the sensor was biased for other test before this stability test. The rest of eight sensors showed stable I-V curves up to 1000V.

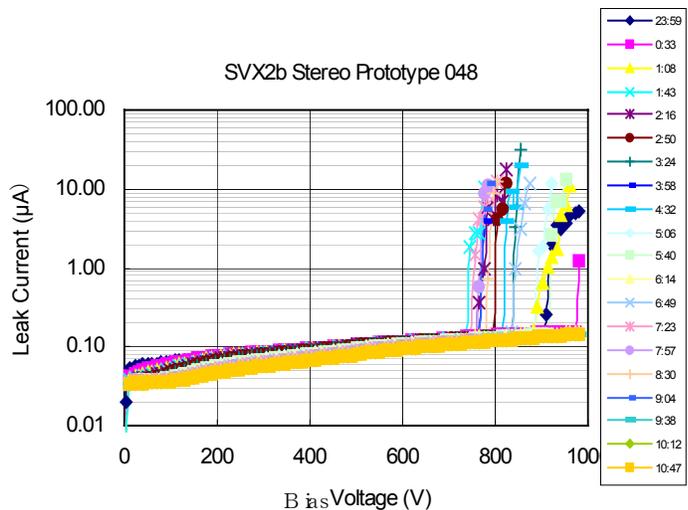
Fig. 2d I-V stability of sensor S048 (stereo).

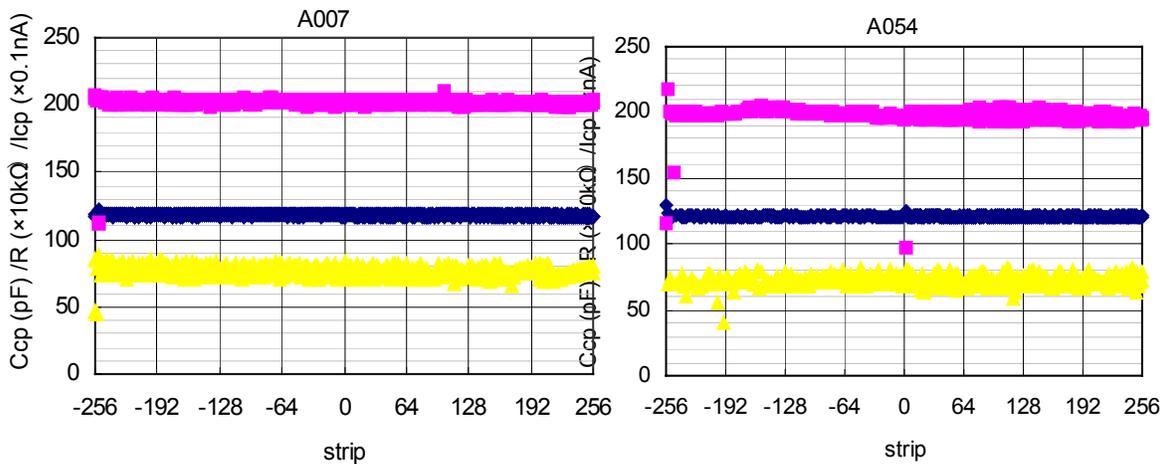
Some example results are shown in Fig.4b, where we found some defective strips. In total, AC scan is made for 18 axial sensors and 18 stereo sensors. The comparison of dead channels reported by HPK is described later.

Fig. 4b AC scan result for (left) axial A007 and (right) axial A054

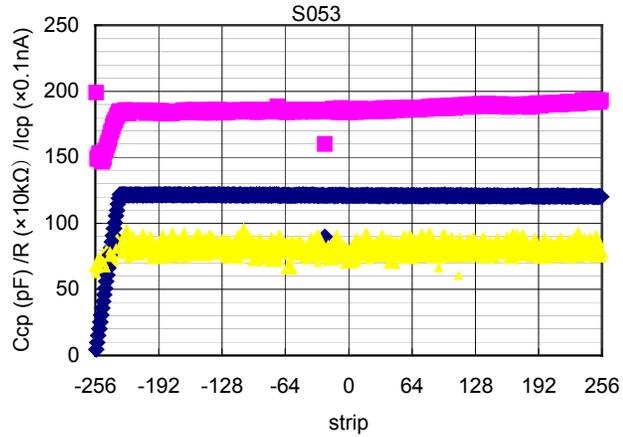
Among the defective strips, there are a couple of cases where Icp is normal but R and Ccp are irregular. An example of such AC scans is given in Fig. 4c, where RD24 (-24 in the plot) has

smaller R and Ccp values but Icp is normal. In this case, we found a clear break in the implant. HPK reports no defect with this strip. Later, we describe this discrepancy further in detail.

Fig. 4d AC scan for stereo S053. One strip (-24) shows irregular R and Ccp values. A clear break was found in this implant strip, while this defect was not recognized by HPK.

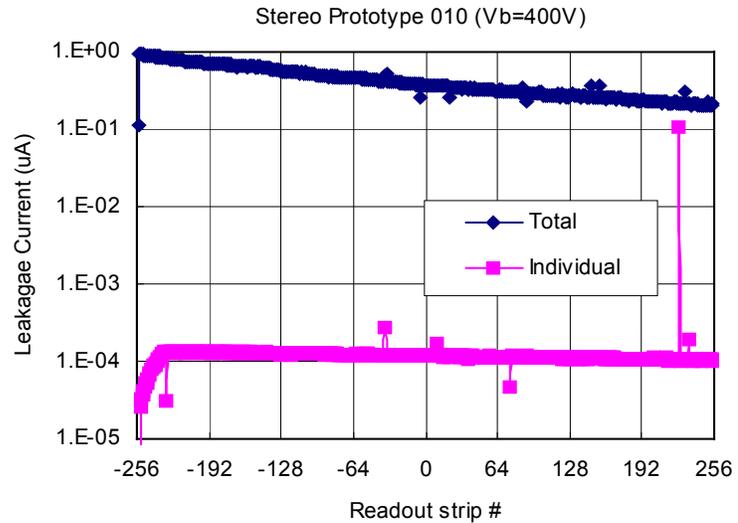
DC scan was made only for leaky sensors. An example result for stereo sensor S010 is given in Fig. 5, where the total leakage current evolution during the measurement is also plotted. The bias is set to 400 V, above the micro-discharge onset voltage. The total leakage decreases as the measurement proceeds (scans from -256 to 256), as we have seen in I-V stability test. Since the total leakage current is about 0.1-0.2 μA for good sensors, the excess of this sensor is initially about 1 μA and finally 0.1 μA . The excess is totally explained by a single leaky strip, U225.

This strip is classified as dead (Leaky) by HPK. Another leaky sensor (stereo S048) has also single leaky intermediate strip, which is identified by HPK.

Fig. 5 DC scan (stereo S010) measured at 400V

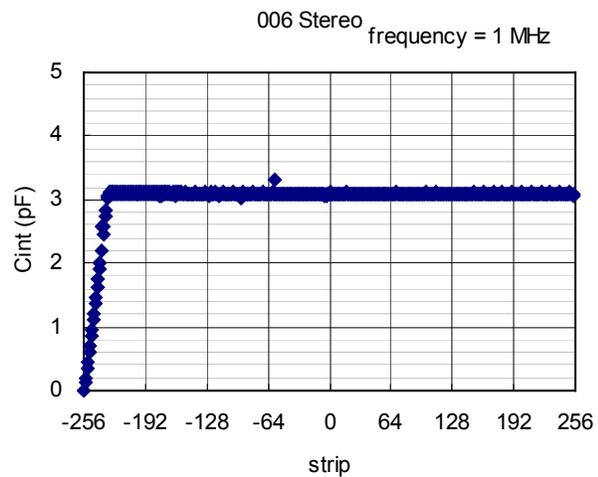
We have measured the interstrip capacitance of in total 9 axial and 2 stereo sensors. Although most of the sensors showed distributions quite similar to those in Fig. 7a, 1 axial and 1 stereo sensors showed irregular values, one pairs for each. An example is given in Fig. 7b. In fact the irregularity for this sensor did not

Fig. 7b Interstrip capacitance: Sensor S006 (stereo) with an irregular value.

present at the first measurement, but it appeared. In the time between the probe scratched out the AC pad by miss-operation. Similar thing may have happened to other sensor, and we suspect these irregularities are created during the testing at Tsukuba. There is no other problem found for these strips by visual inspection under microscope.

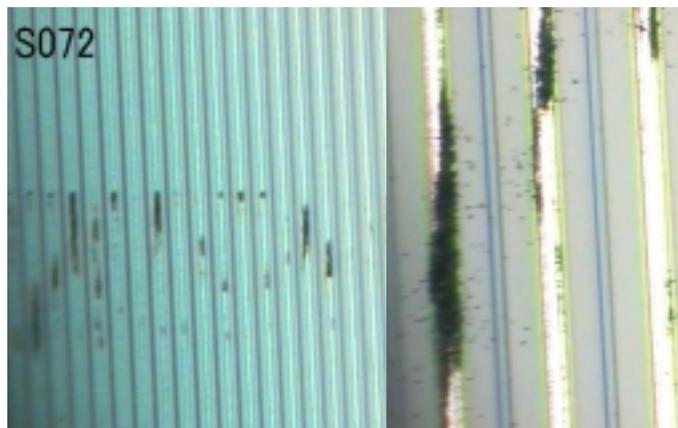
The axial sensors are in general clean and we did not recognize major flaws. As described in Section 2, though, the stereo sensors showed visible problems. Figure 8a is a typical picture found for about 1/3 of delivered stereo sensors. They are classified as Class B, since visual inspection does not pass the criteria. Enlarged view (Fig.8a right) shows that the black stains are on the very surface of Al traces. As explained before, these were created when the wafers were taken out manually from the process line, which is not expected to happen in the production. We checked whether there are any correlations between faulty strips and the stains, and between magnitude of stains and shape of I-V curves, but there are no apparent correlations.

Fig. 8a Example of stains observed for stereo sensors. (Right) Enlarged view.

From these observations, we conclude that these sensors are good in electrical performance. We classify them as Class B (do not use them, unless delivery becomes a major problem for completion of the project).

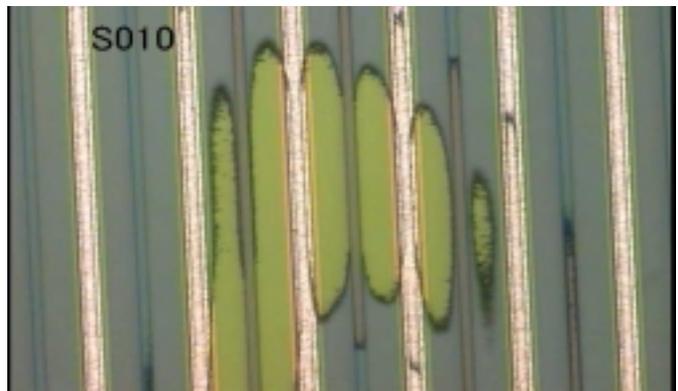
A yellow spot shown in Fig. 8b is found only for S010 sensor. Stereo S010 sensor showed micro-discharge, but the contributing strip is not the one in this yellow spot.

Fig. 8b Yellow spot found for Stereo 010 Sensor.

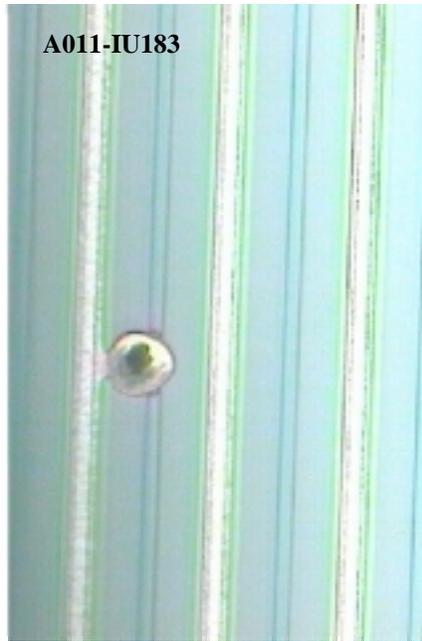
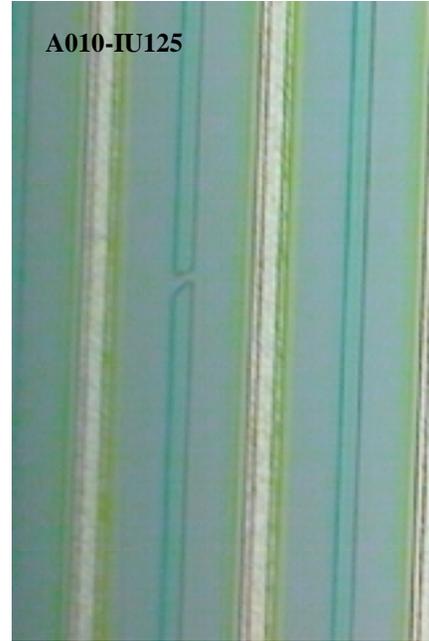
Figure 8c shows examples of implant opens both for intermediate strips. The open for A011 sensor is exceptional, and all the other opens look similar to the one found for Axial 010 Sensor (intermediate strip IU125).

Fig. 8c Examples of implant opens. (Left) Axial 011 Sensor and (Right) Axial 010 Sensor

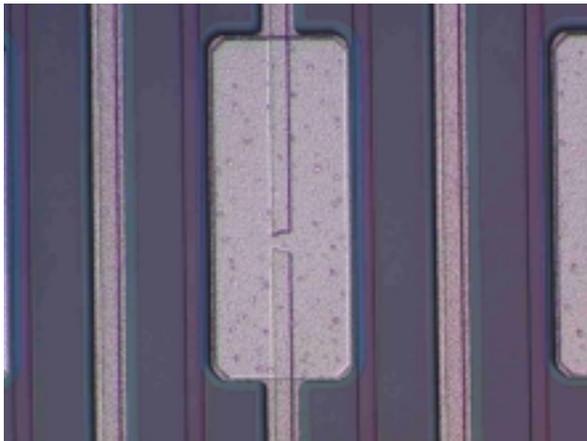
Some opens are found in the readout implant, one example being shown in Fig. 8d. This is a special case that the break is located underneath the Al bonding pad. Although AC scan at Tsukuba first detected the irregularity of this strip, we failed to find this open under microscope. This sensor was then sent back to HPK for investigation, where this open was identified. This lessons us that very careful inspection is required to find the implant open which is partially hidden by Al electrode on top.

Fig. 8d Readout implant open found underneath the AC pad.

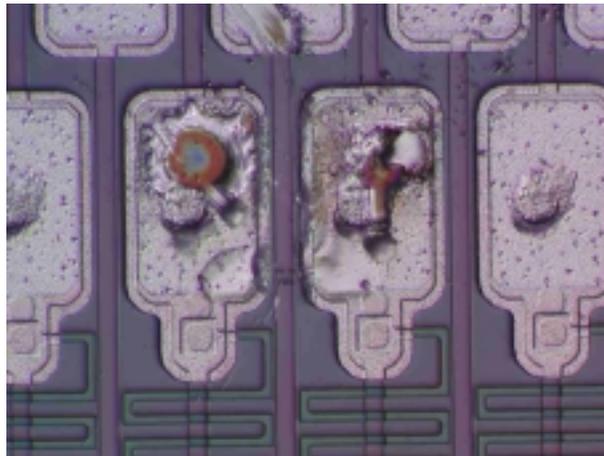
After all, two strips (Sensor 7, RD251 and RD 252) were new and not clearly understood. This sensor (and some other sensors) was sent back to HPK to investigate the problem. According to HPK investigation, small discharge should have happened. The photograph taken by HPK is shown in Fig. 8d. The DC pads of these strips are colored and black discharge traces are visible bridging the two pads.

Fig. 8d Photograph around DC pads of RD251 and RD252. Two black traces are visible bridging the two DC pads. (Photo taken by HPK)
