Characteristics of Prototype Silicon Sensors for CDF Run2B

K. Hara, U of Tsukuba

summarizing tests done at Tsukuba/Purdue/UNM

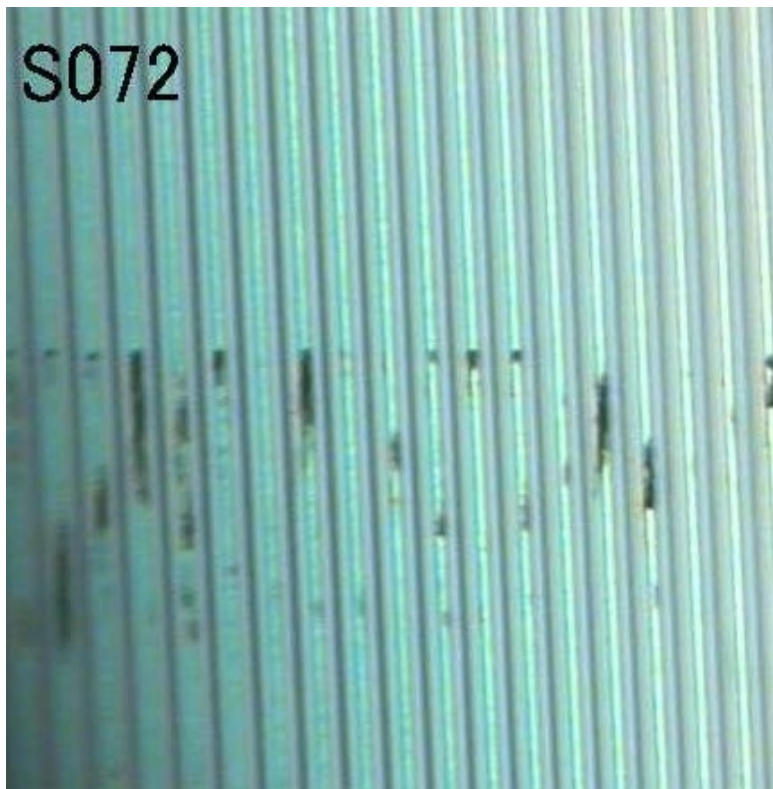
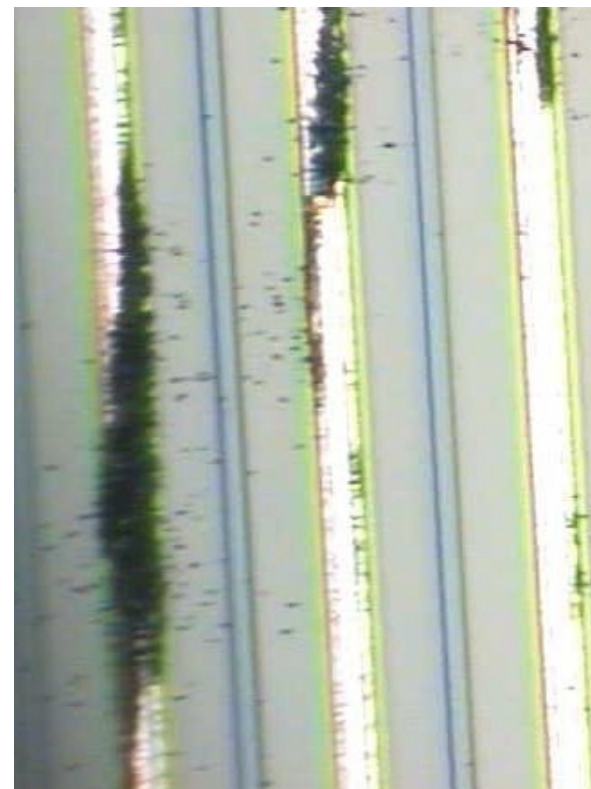
~1/3 of stereo: unusual stains
no apparent effects on sensor performance

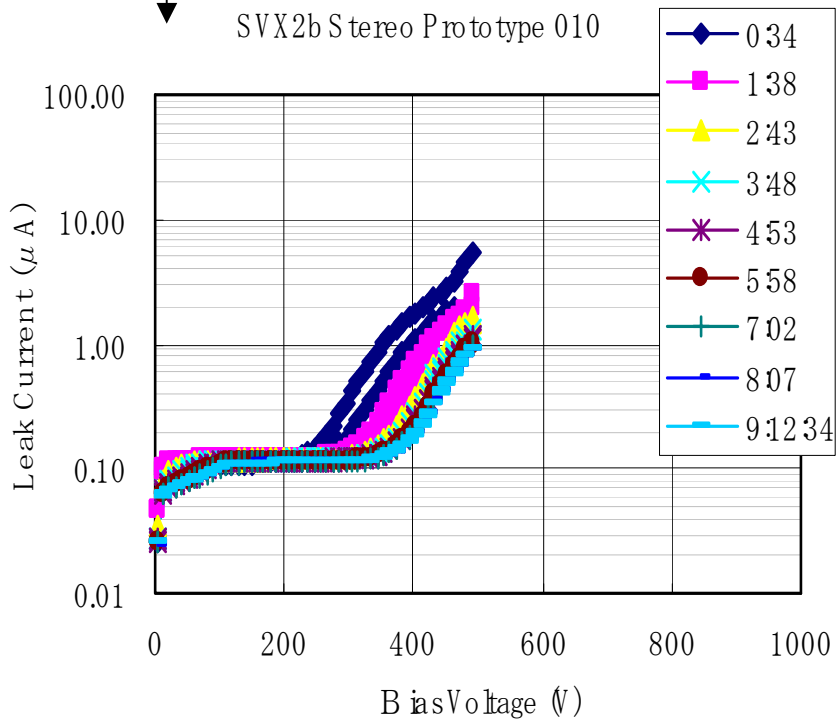
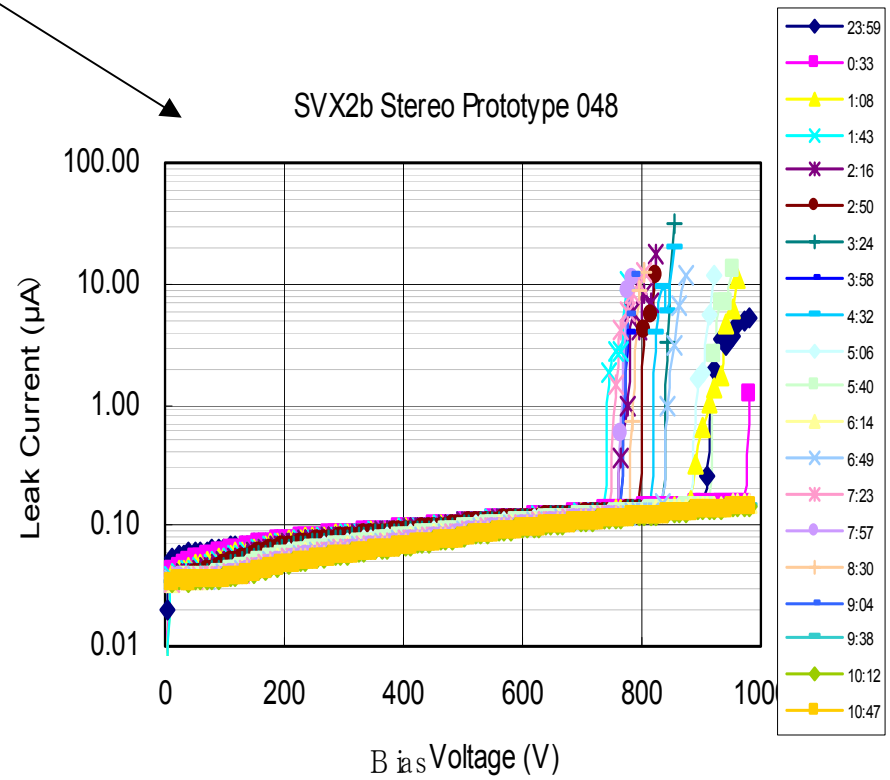
two sensors with micro-discharge

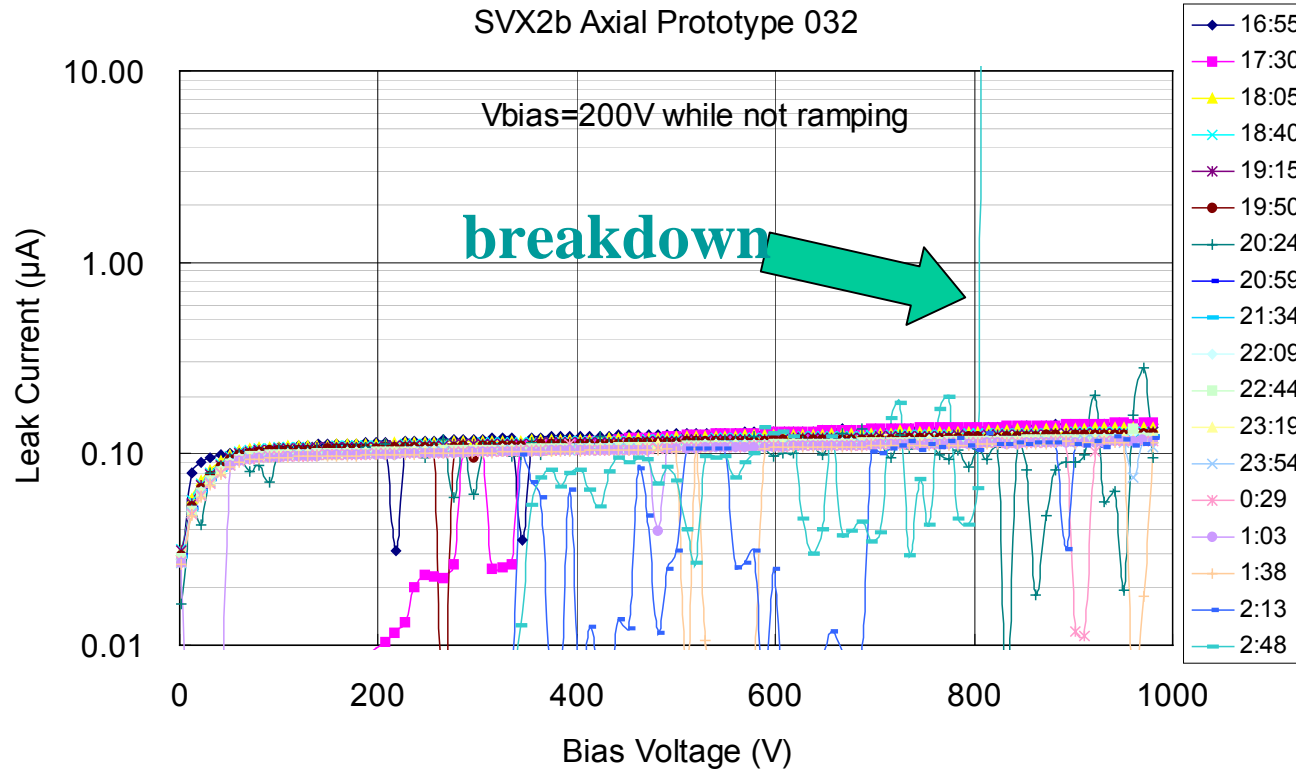
IV stability (bad axial)

A032 showed instability at later stages (~7hrs)
breakdown at HV ramping (at 800V after 10hrs)

Out of 16 sensors, we found one bad sensor...

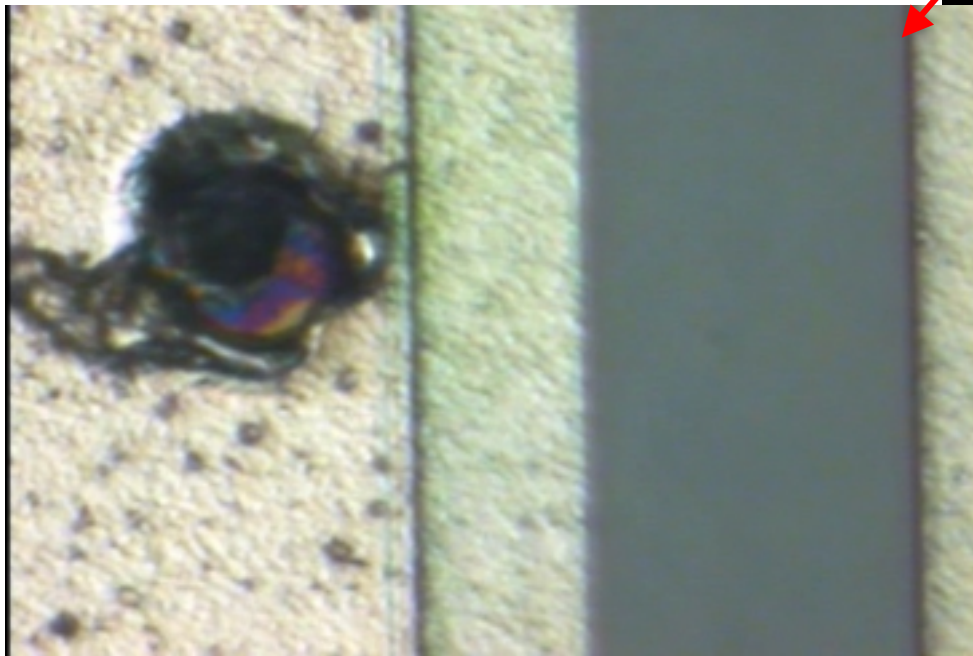
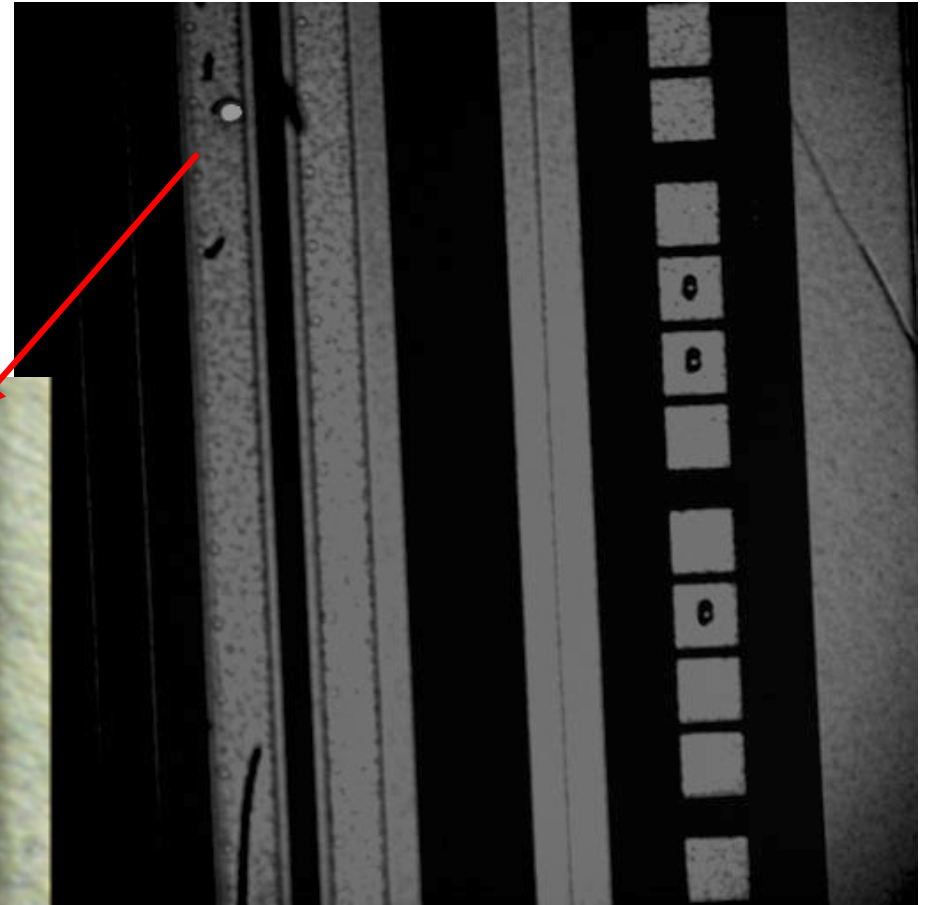
IR camera view:

clear trace of discharge

junction breakdown: no recovery

We must respect the spec (500V)!?

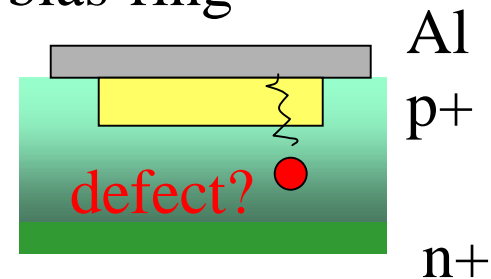
bias-ring

scratch degrades I-V stability?

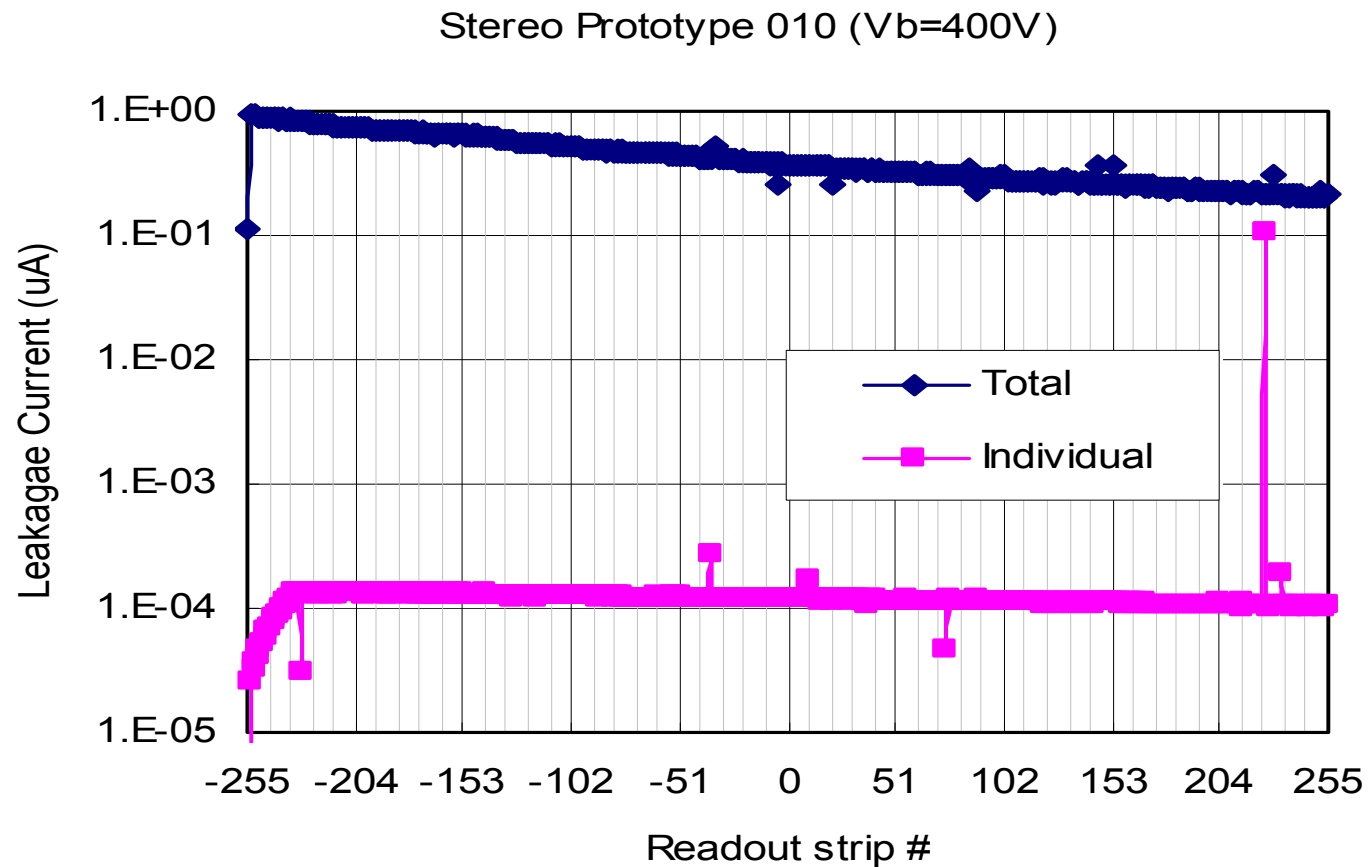
Fig. 5 DC scan (stereo #010) measured at 400V

RU225: HPK leaky

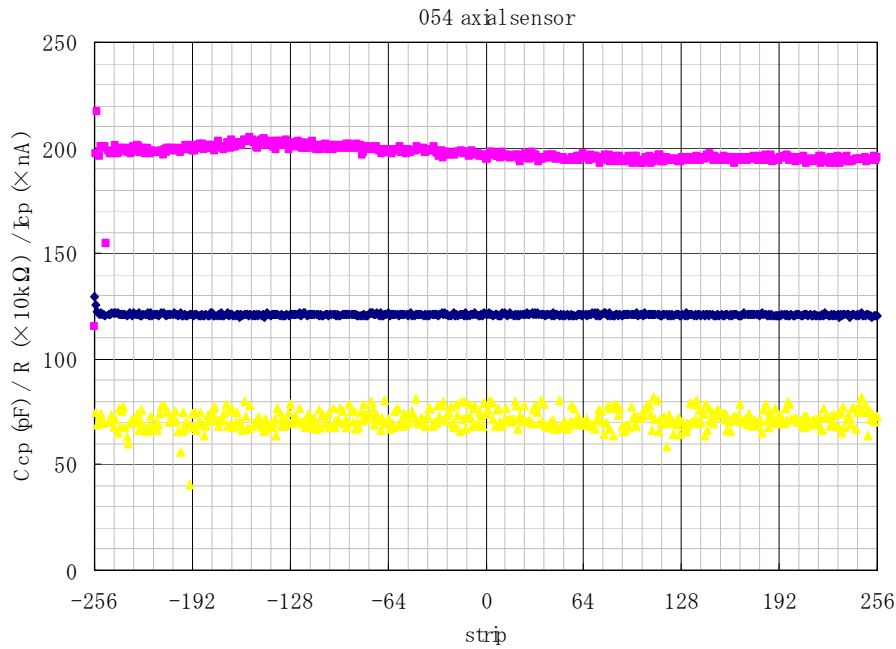
054 axial

RD256
RD249
RD248
RD244

punch-through
Icp is large

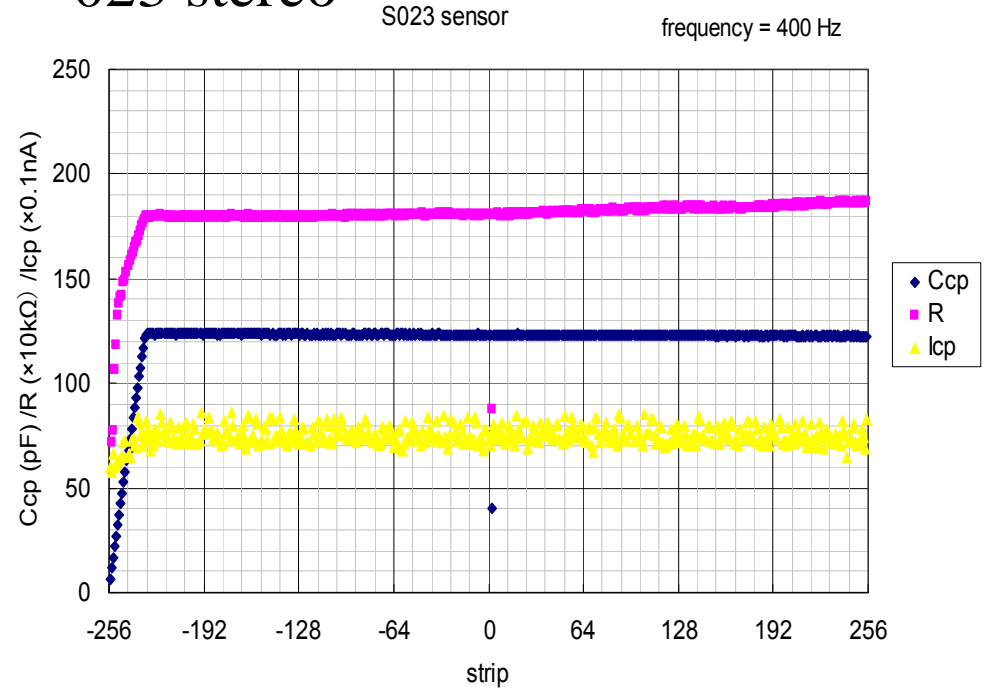
023 stereo

RU2 implant open
open is identified with microscope

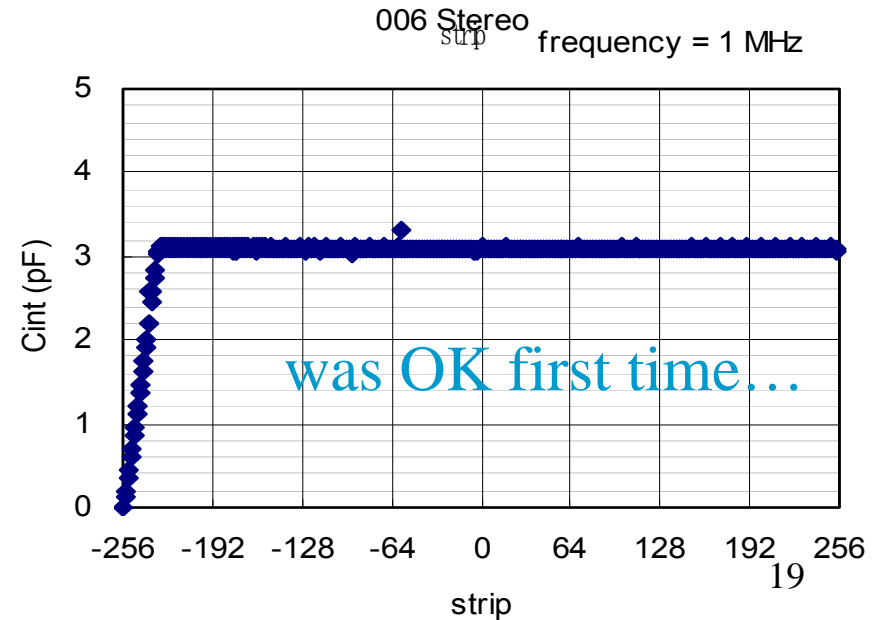
All looked similar except #007
 C_{int}(R5-R6) is high ...
 R5 & R6 showed smaller R

Fig. 7b Interstrip capacitance: Sensor 006 (Stereo) with an irregular value

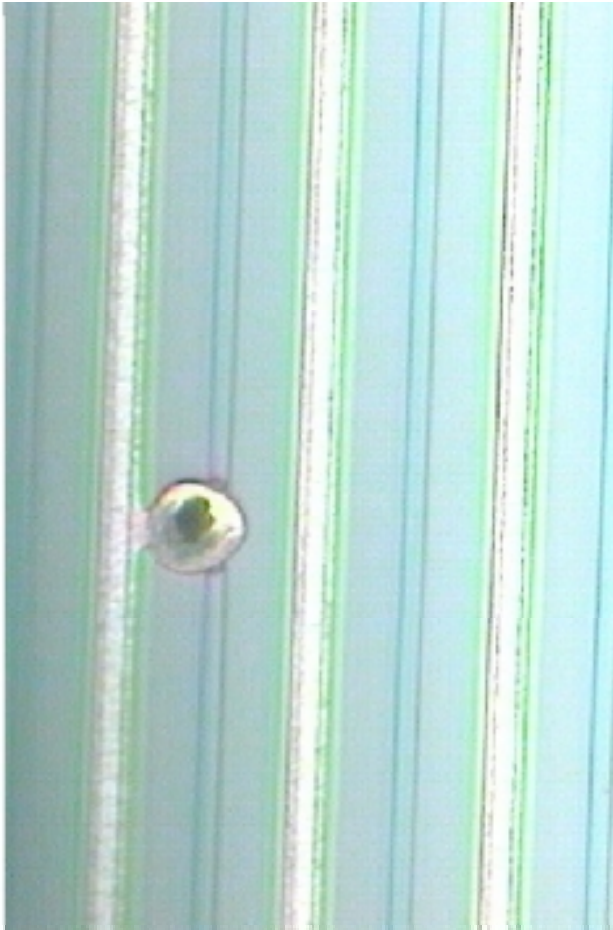
just one case

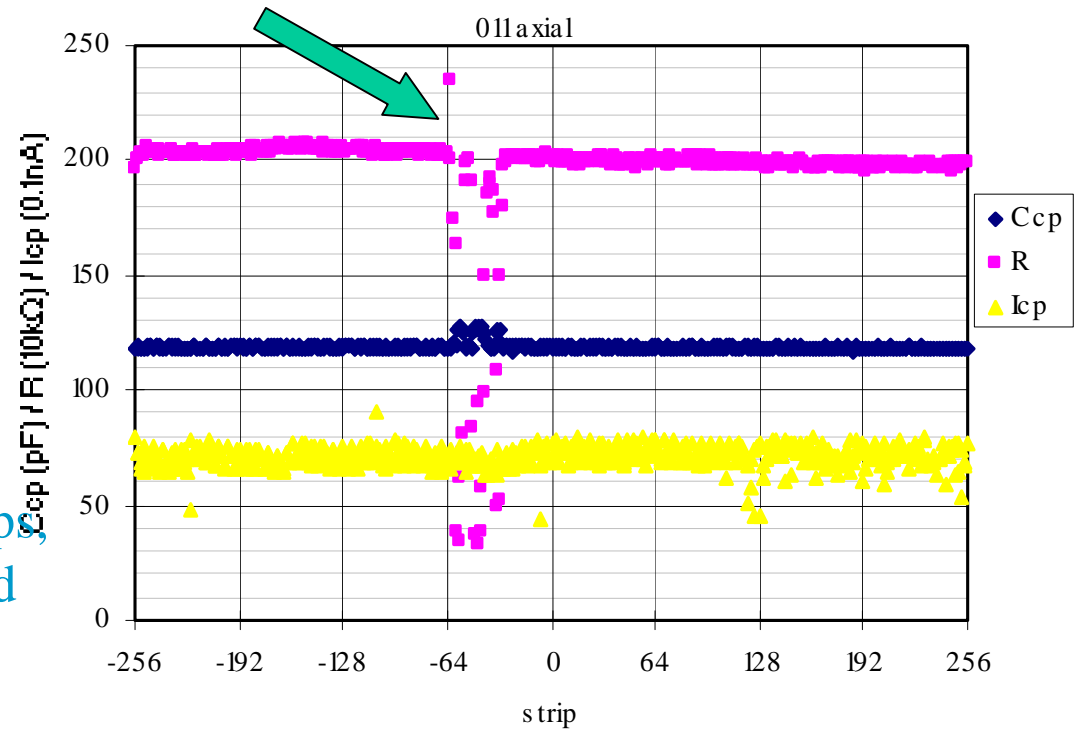
In early stage, we often got bad distributions (R/Ccp e.g.)

symptom: **isolation degrad.**

From the location and size of bad strips, we suspected vacuum tweezers caused charge-up on sensor surface

After eliminating use of tweezers, only a few “charge-up” channels much less frequently

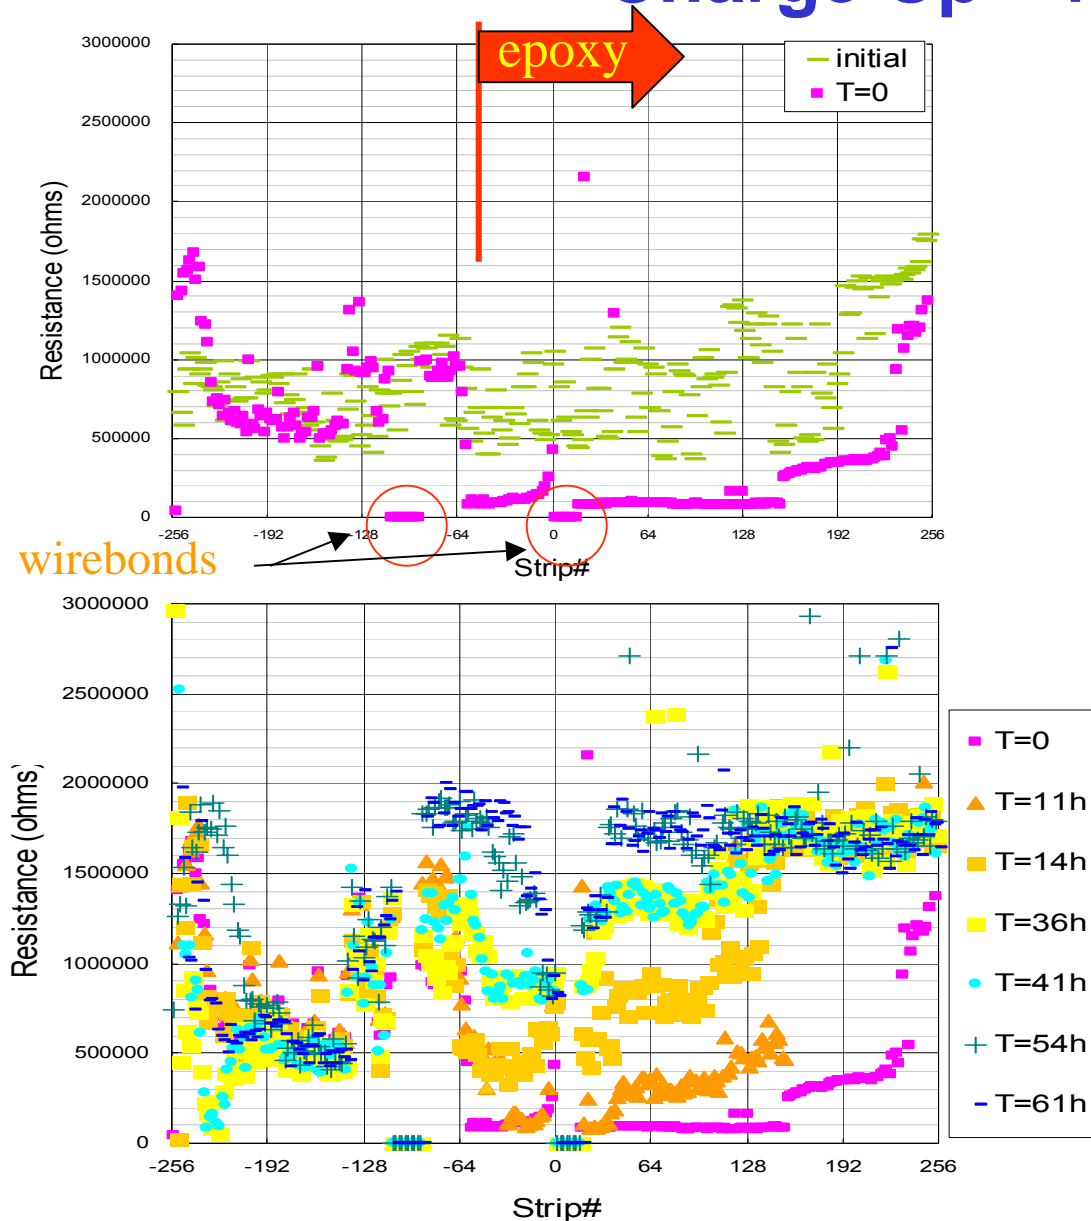
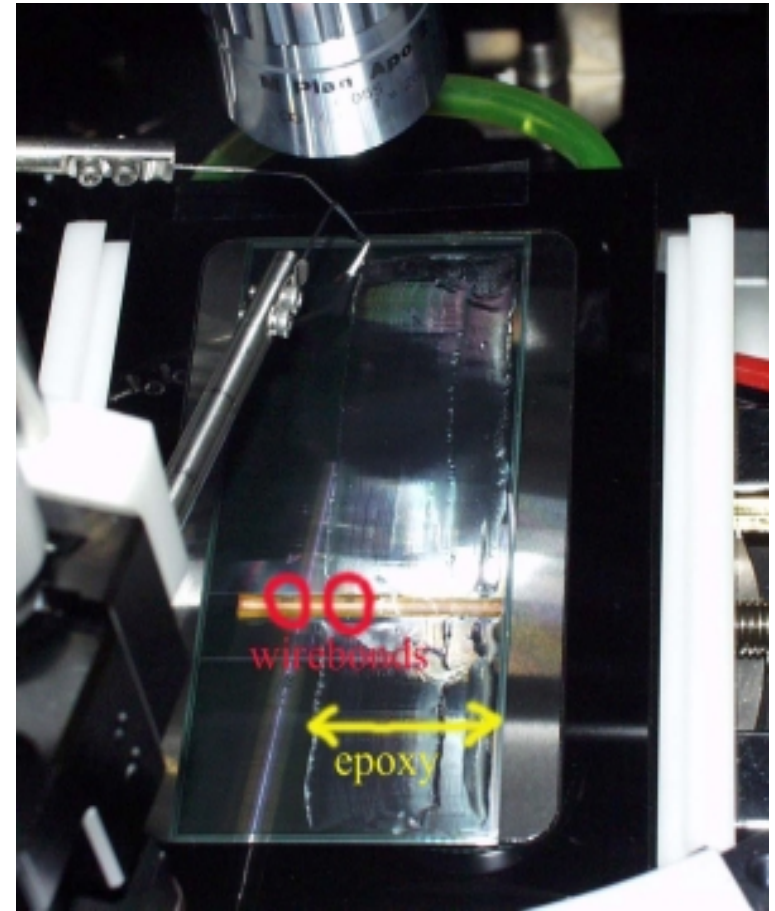
a sample heavily charged up
 apply epoxy (Araldite 2011)
 some Al strips wire-bonded

- (1) recovery around bonded strips
- (2) no recovery in isolated area for 61h
