# Preparation of pixel module production for the HL-LHC ATLAS ITk

*Koji Nakamura (KEK)*

*on behalf of ATLAS Japan Itk group*

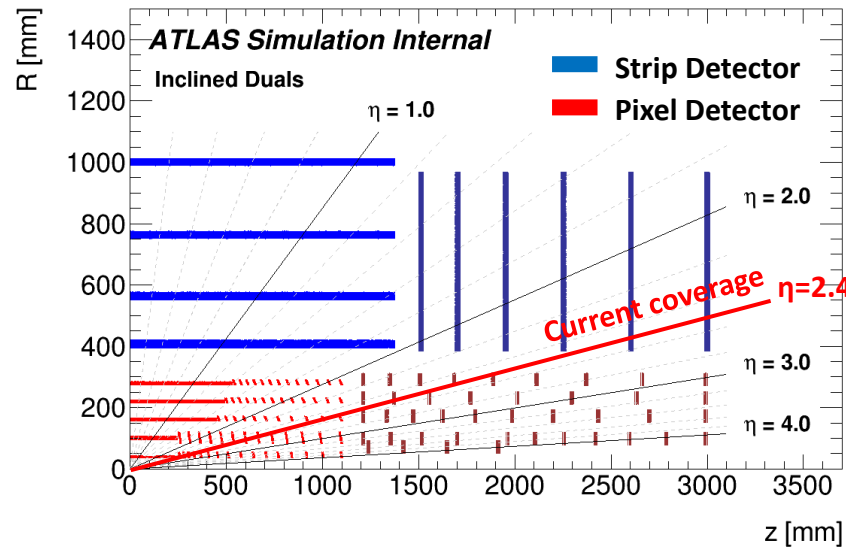
Type of sensors
Layer 0	3D type
Layer 1	Thin planar(100um)
Layer 2-4	Thick planar(150um)

- Larger coverage area
  - Pixel : current 2.7m<sup>2</sup> → **upgrade 8.2m<sup>2</sup>**
  - Strip : current 34m<sup>2</sup> → upgrade 165m<sup>2</sup>
- Higher Forward coverage
  - Current  $\eta < 2.5$  → **upgrade  $\eta < 4.0$**
  - **Better Pileup removal & background rejection**
- For Layer 1-4, constructing Quad module
  - Size : 40mm x 40mm
  - Single sensor with 4 Front End ASIC bonded.

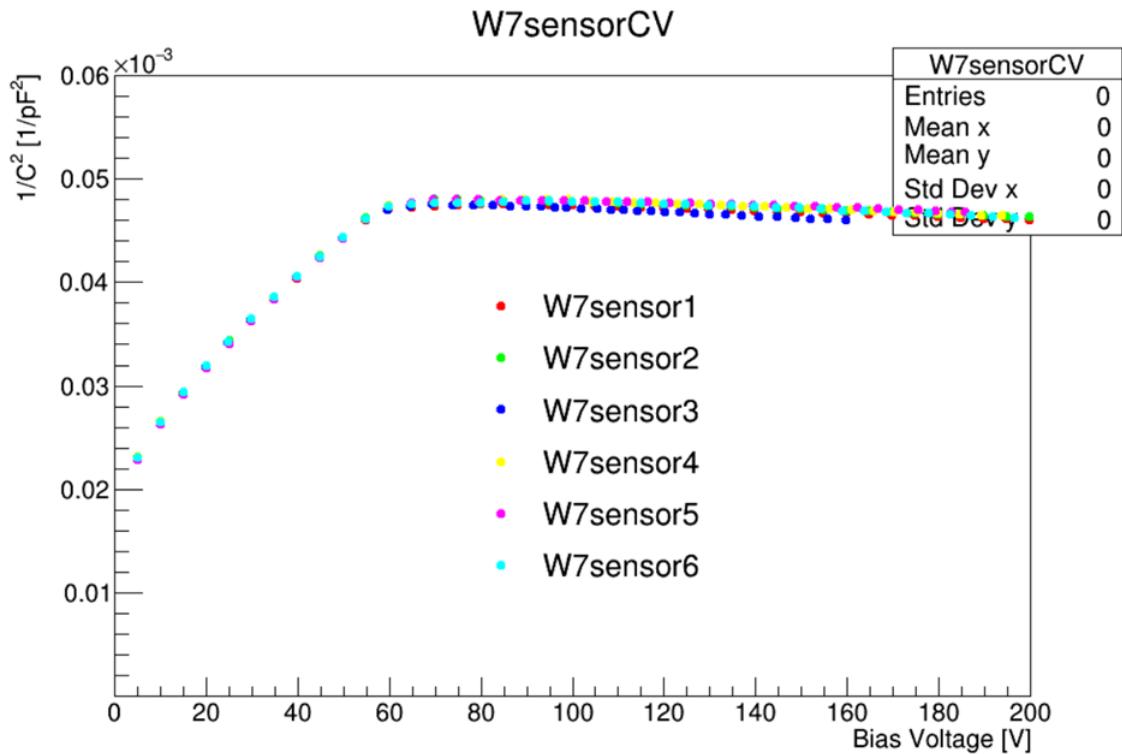
- CV measurement
  - 6 main sensors has been measured.
  - KEK: 20°C RH<5%

**Requirement :  $V_{dep} < 100V$**

Analysis and comparison to HPK data still on going.  
(but  $V_{dep}$  is clearly satisfied the requirement)

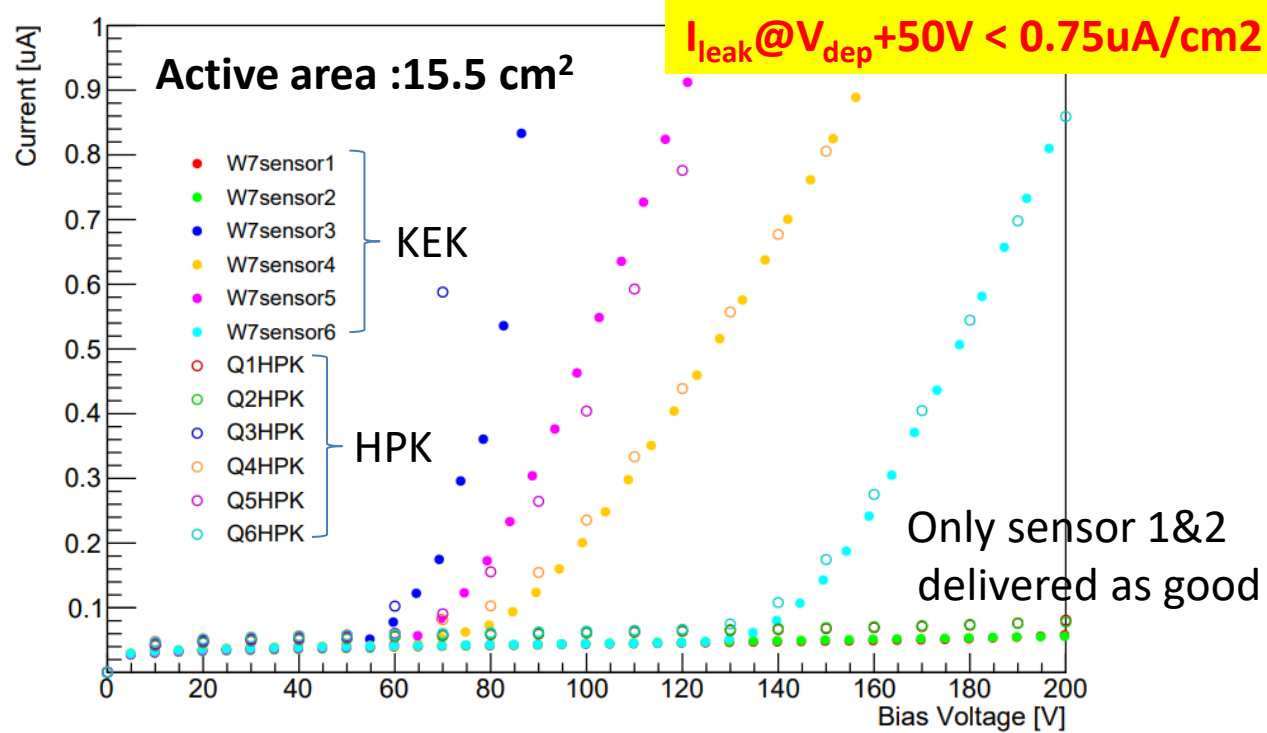
- IV measurement
  - 6 main sensors has been measured and compared with HPK measurement
  - KEK: 20°C RH<5% HPK : 23°C RH~40%

**Requirement :  $V_{bd} > V_{dep} + 70V$**

Leakage current and  $V_{bd}$  agreed well **2.8-2.9 nA/cm<sup>2</sup>**

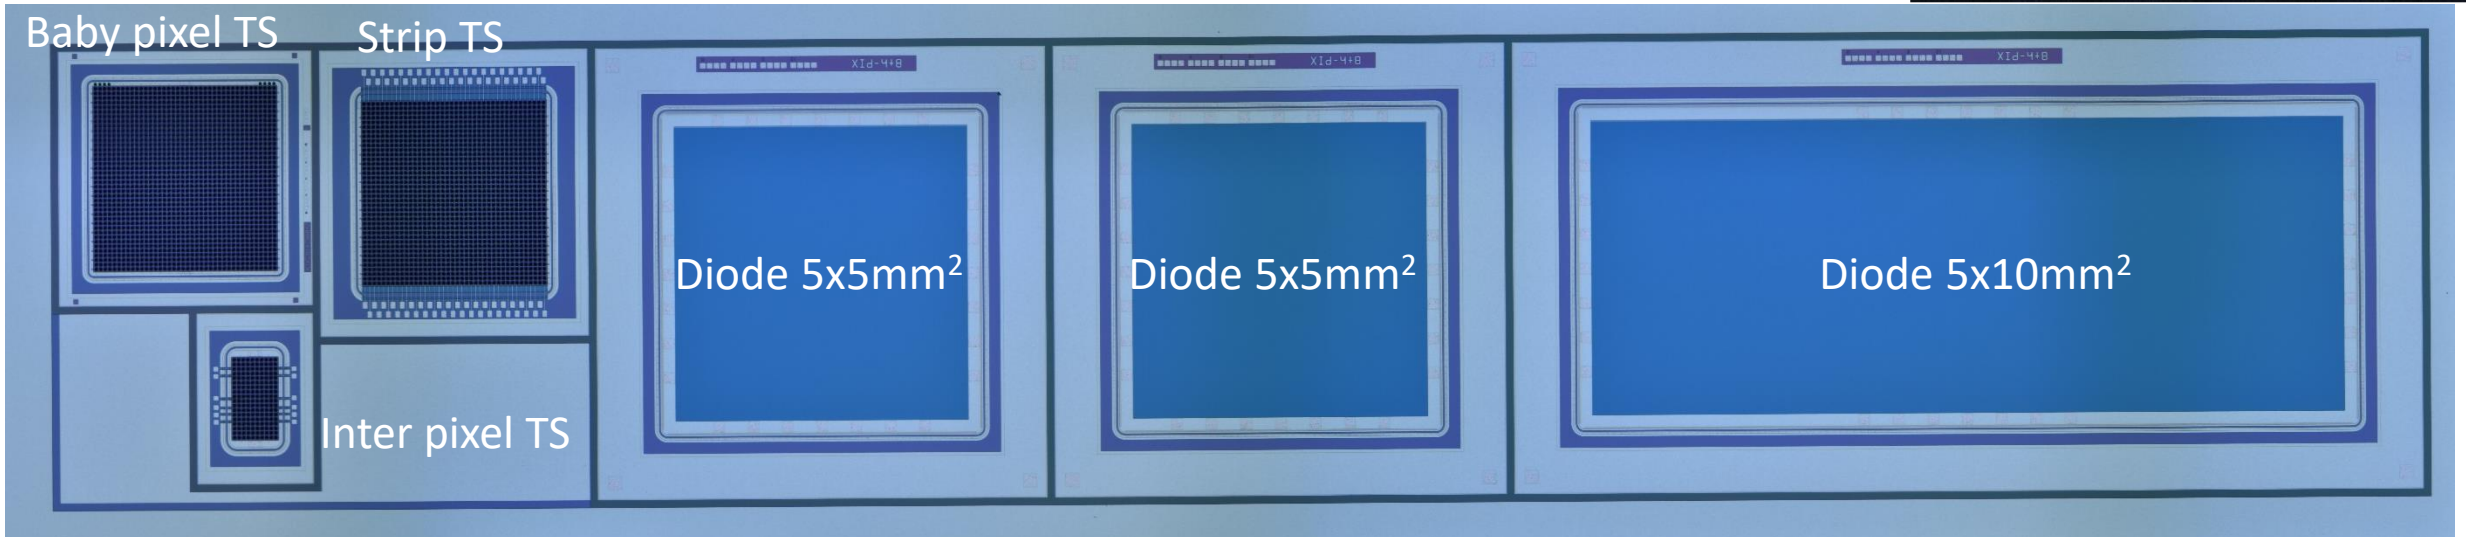
- Not required but took high resolution picture.
  - Found that no-scratch mark in Test structure...
    - Made feed back to HPK and will be improved in production

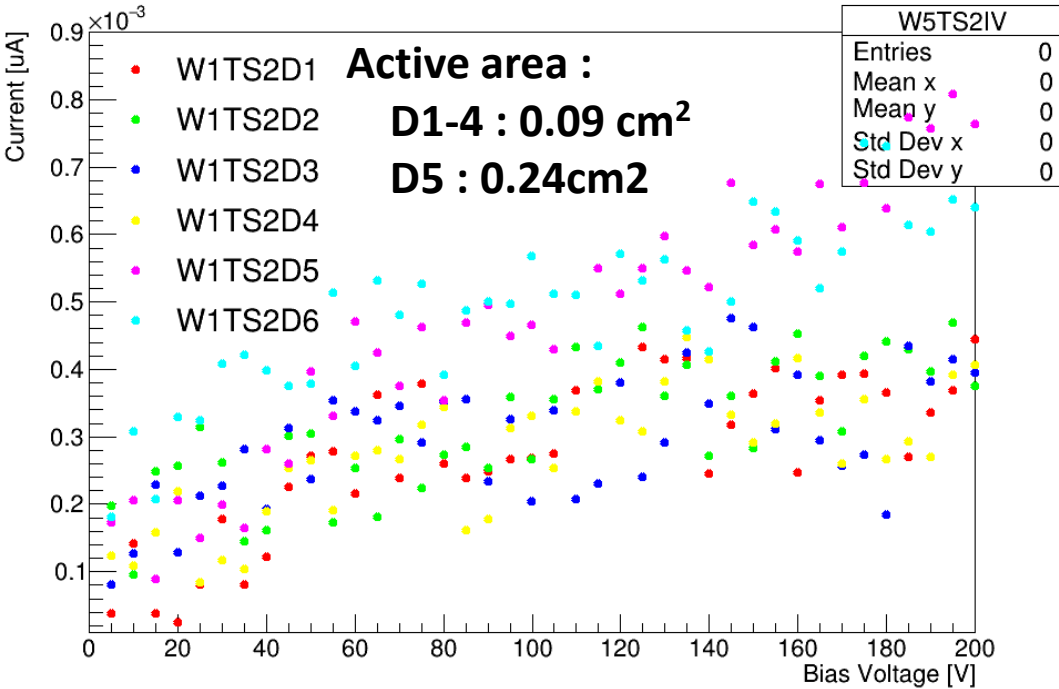
W5TS2IV

Leakage current is extremely low (~0.5nA)

May not be sufficient measurement...

3.5-4.4 nA/cm<sup>2</sup>

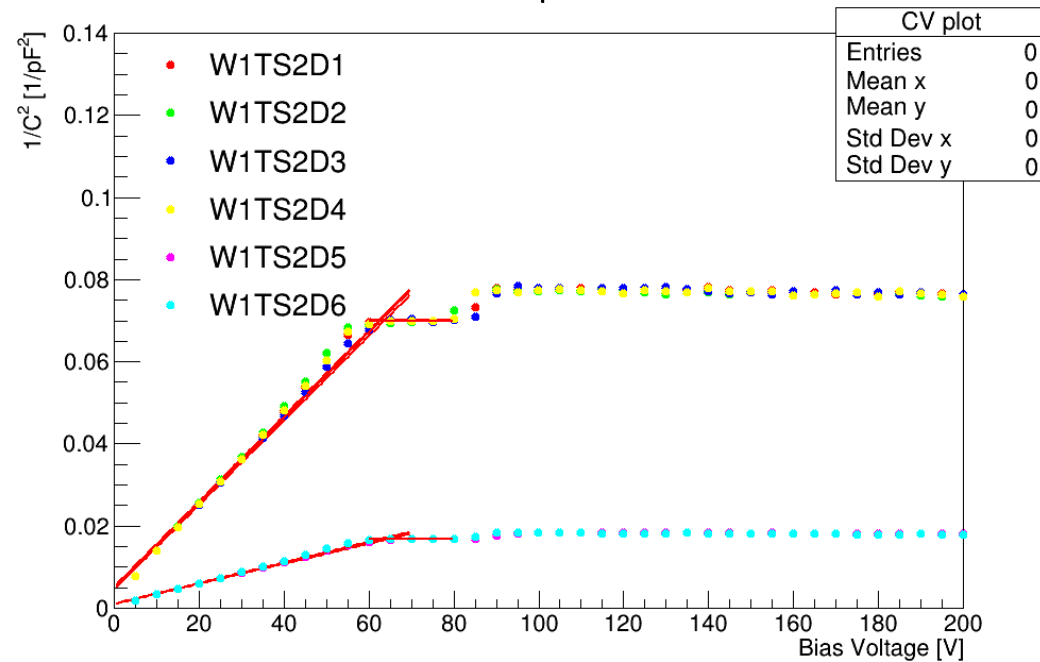
CV plot

Strange step at shoulder (probably due to edge effect?)

A bit hard to conclude Full Depletion voltage from this measurement.

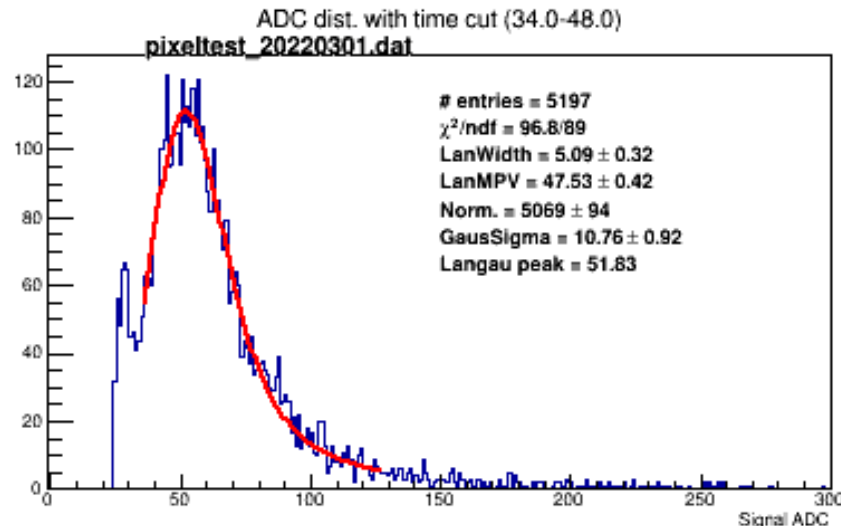
- Measured one of strip TS by Alibava setup.
  - Used  $^{90}\text{Sr}$  source with scintillator trigger.
  - LandauMPV=47.53±0.42 ADC count  $\sim 8570 \pm 76 e$
  - Smaller than expected. (due to inter strip capacitance?)

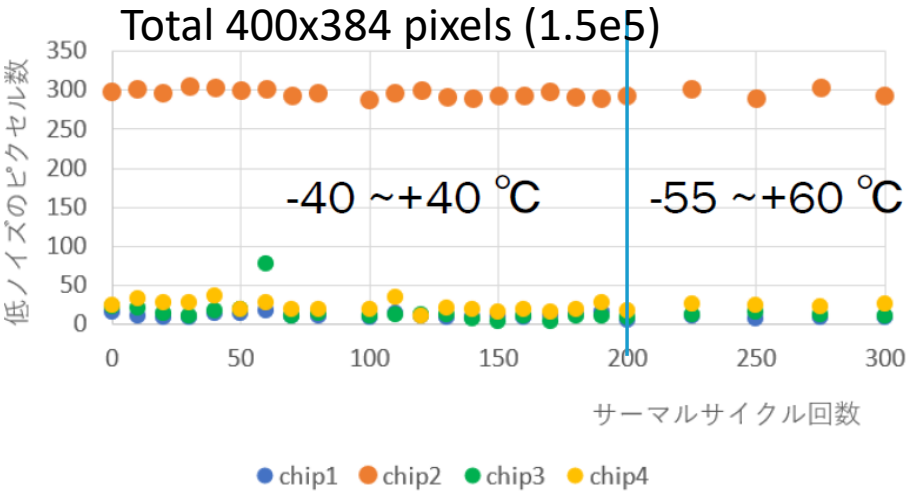
- CTE mismatch introduce stress to the Bump
- Checked bump connectivity after thermal cycle
  - Checked number of disconnected bumps as a function of number of cycle. (subtracted initial failure)
  - Additional 5 modules are tested to increase statistics.
  - **No visible increase of bump delamination observed.**

Only one module has been tested at the time of Nov

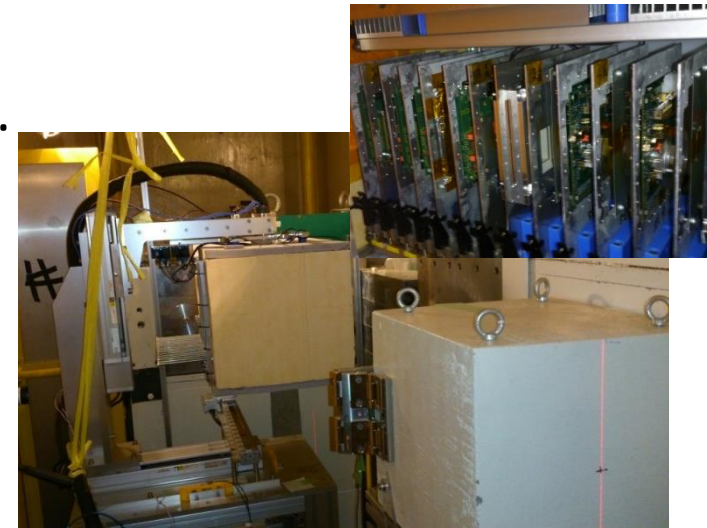
- To check bump stress issue after irradiation
      - Especially Parylene performance after irradiation
    - One of 4 modules are irradiated with chip operation

- We should know the radiation effect to the CMOS FET
      - Checked stability of regulator/reference voltage/ring oscillator

- Irradiated module with proper cooling system.
  - Kept module temp  $\sim -15^{\circ}\text{C}$
- During irradiation chip was operated and measured various parameters.
  - Ring Oscillator Frequency went down (15%)
  - Reference voltage going up (5%)

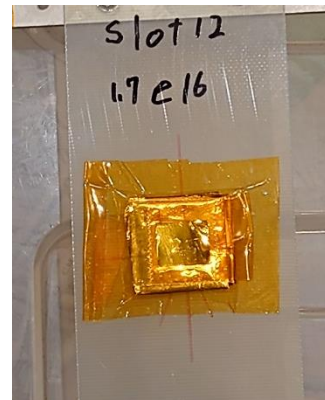
No way to handle  
without touching surface soft UBM...  
Glued to PCB.

Irradiated successfully except  $2 \times 10^{15}$  Test structure

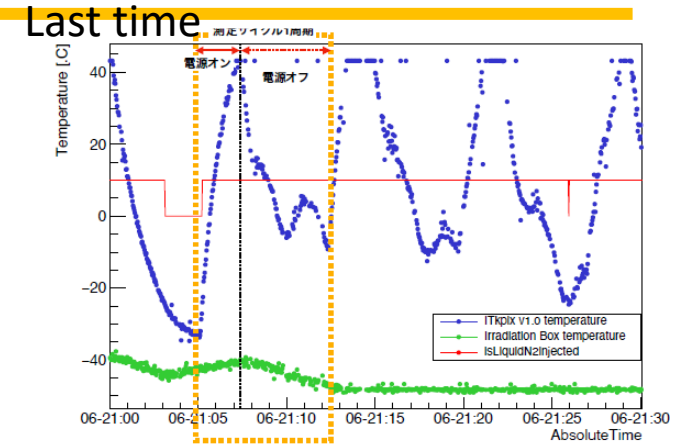
- In previous irradiation we observed rapid temperature ramp when chip LV turned on. → LV off after measurement.
- Better cooling system has been developed and successfully operated with  $[-15, -10]^{\circ}\text{C}$  temperature range!

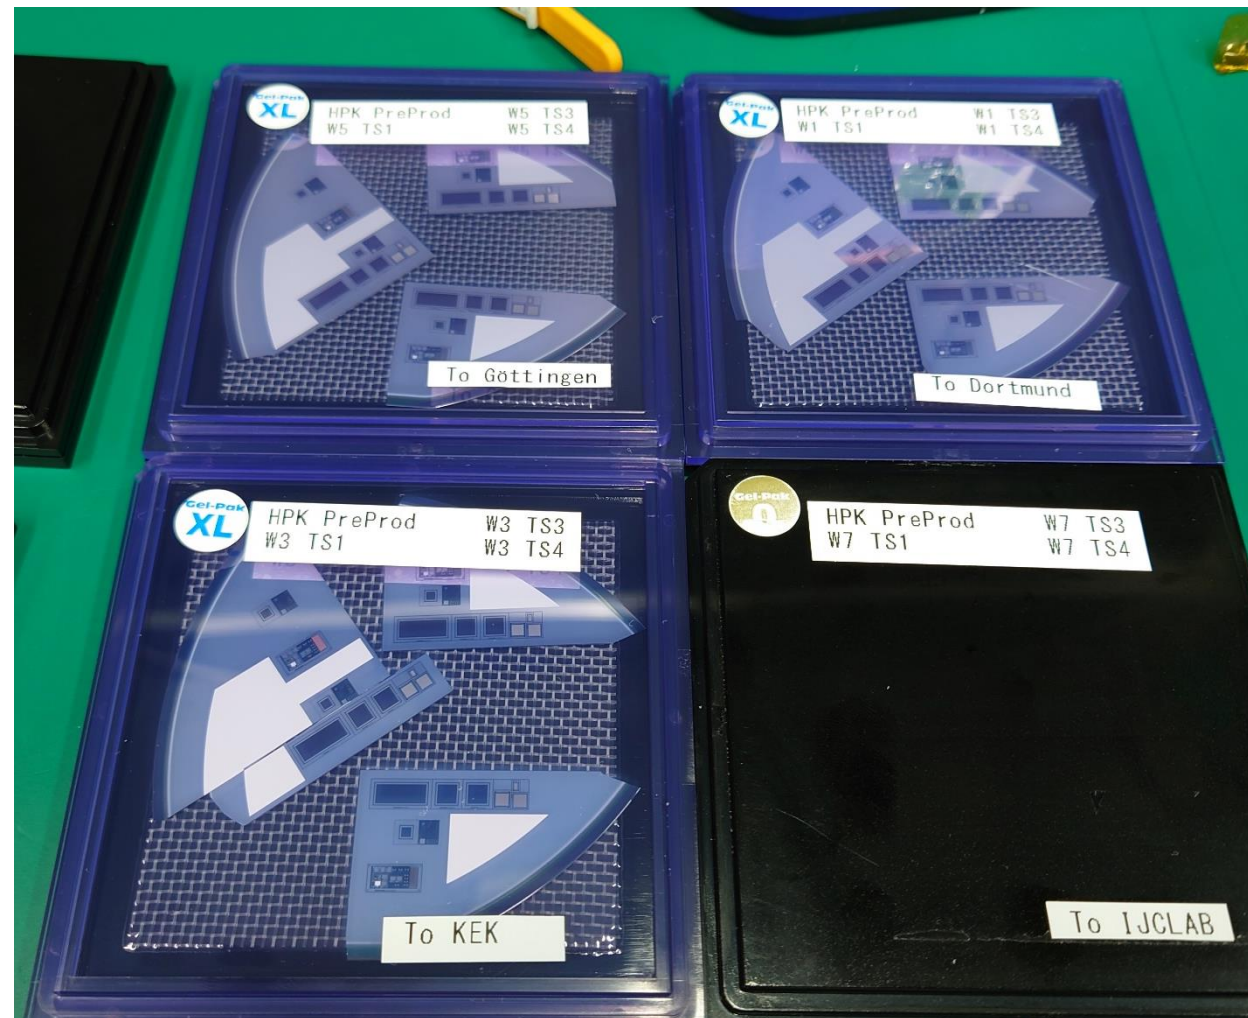
- each gel-pack contain P1,P3,P4
  - To Goettingen : w5-P1,P3,P4
  - To Dortmund : w1-P1, P3, P4
  - To IJC lab : w7-P1, P3, P4
  - Keep one at KEK : w3-P1, P3, P4

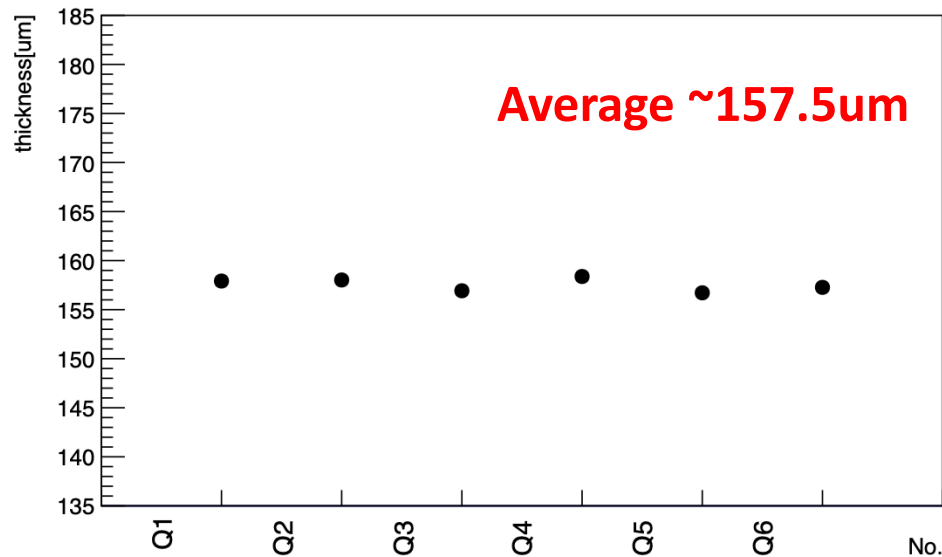
- Hight measurement with Vacuumed chuck on
- Take average of height for points scanned with 2mm steps (2D)

Matching to Specification :  $150 \pm 15 \mu\text{m}$

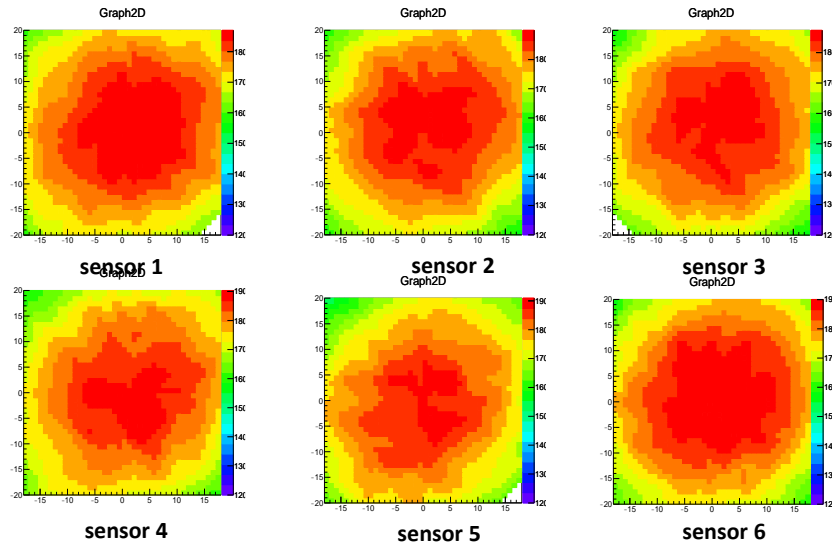
- Hight measurement without Vacuumed chuck on

All sensors have quite similar shape

Height differences are 20-35μm after slope correction

Not within <math>< 25 \mu\text{m}</math> specification(?) → may be ok since FC by HPK
