Characteristics of Prototype Silicon Sensors for Run2b

K. Hara and Y. Takei

University of Tsukuba, Tsukuba, Ibaraki, Japan

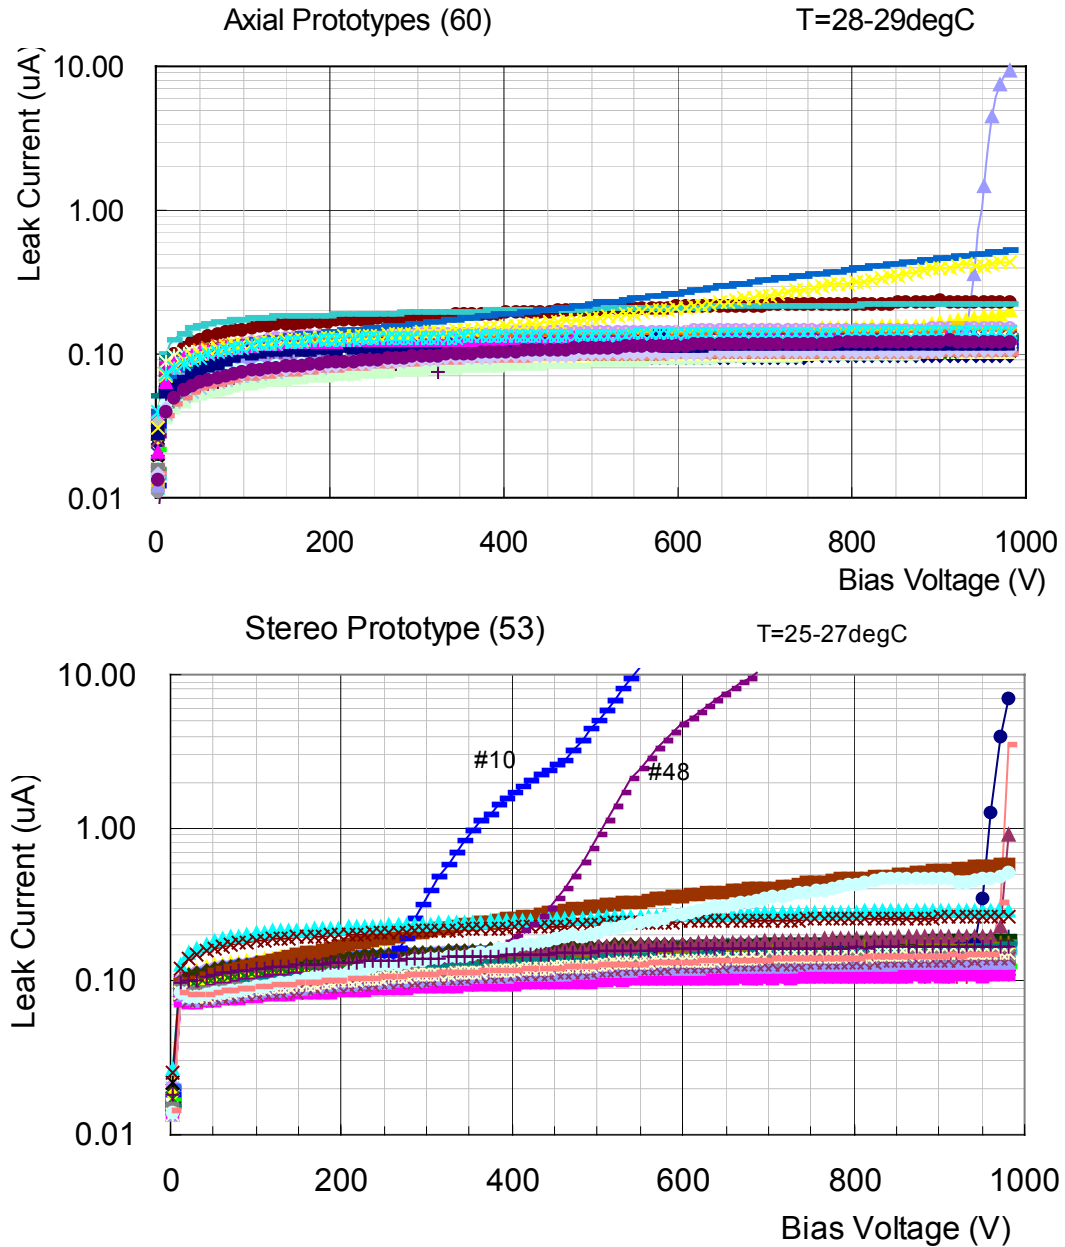
Figures 1a and 1b show I-V curves of 60 axial and 53 stereo sensors. Most of the sensors do not show significant micro-discharge up to 1000V we measured. Exceptions are #010 and #048

stereo sensors, which showed micro-discharge at voltages above 300V-450V. As described in 3.5, single leaky strip contributes to the micro-discharge for both sensors. The I-V curve of these sensors tend to become moderate as bias is kept applied, as described in 3.2. We set our leakage current requirement less than $2\ \mu\text{A}$ at 500V so that no single readout strip has significant leakage current, $\sim 1\ \mu\text{A}$, which degrades the noise performance. In this view, all the sensors fulfill our specification (#010 stereo is just on the boundary). Actually substantial fraction of ISL sensors had leakage current close to even a relaxed specification. The present prototypes are roughly one order better in the leakage current. We should, though, avoid using these two sensors as far as the

Fig. 1a (top) I-V curves of 60 axial sensors.

Fig. 1b (above) I-V curves of 53 stereo sensors.

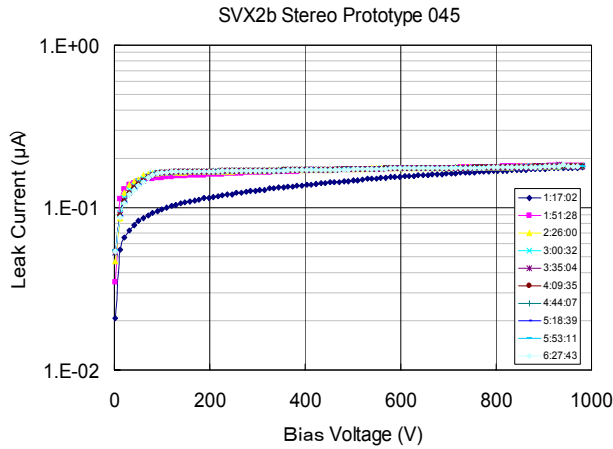
Fig. 2a Typical I-V stability of sensor #045 (stereo).

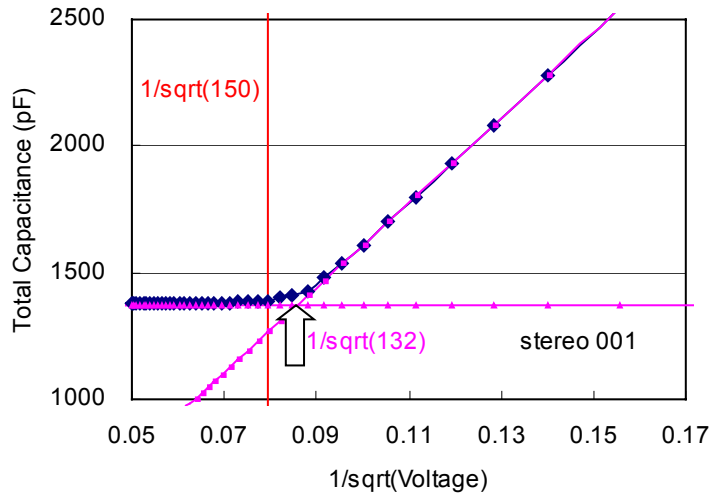
Fig. 3a C-V curve and evaluation of “the full depletion voltage”. HPK determines (see text) it to be 150V, whereas we obtain 132V for this sensor, stereo #001.

We extract the full depletion voltage as the intercept of two straight lines in a $C-V^{-1/2}$ plot (see Fig. 3a). HPK measures C-V at a voltage step of 10V. The data is used to evaluate the “full depletion voltage”, which is defined to be the lowest voltage where the increase of $1/C^2$ is found to be less than 2%. There is a tendency that HPK gives somewhat larger voltage, as can be seen in Fig. 3b. The distributions of Tsukuba data (axial and stereo separately) and of HPK are given in Fig. 3c. The spread of the distributions are similar, indicating that the full depletion voltages are extracted consistently apart from the absolute value. As a matter of fact, the value 2% is an arbitrary choice so that no fitting is

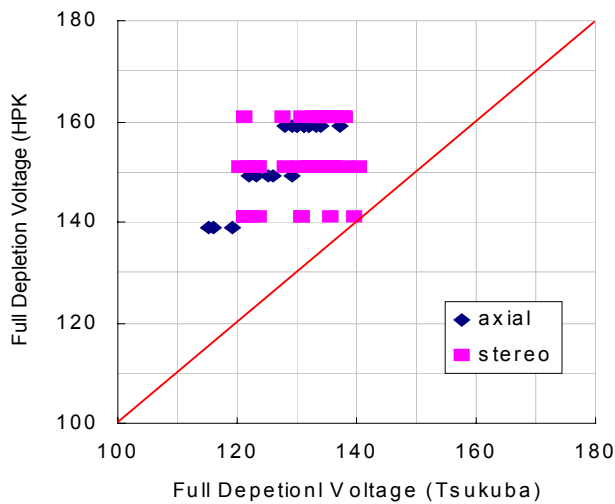
necessarily performed. For a choice of 4%, the agreement between the two should be improved. Three sensors have failed in the full depletion voltage specification, but all of them are more than 115V.

Fig. 3b Correlation of full depletion voltages defined by HPK and Tsukuba.

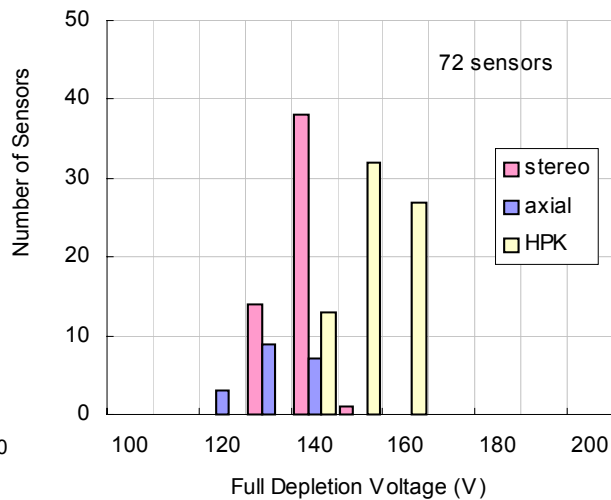
Fig. 3c Full depletion voltage distributions for axial and stereo sensors (Tsukuba) and for all (HPK).

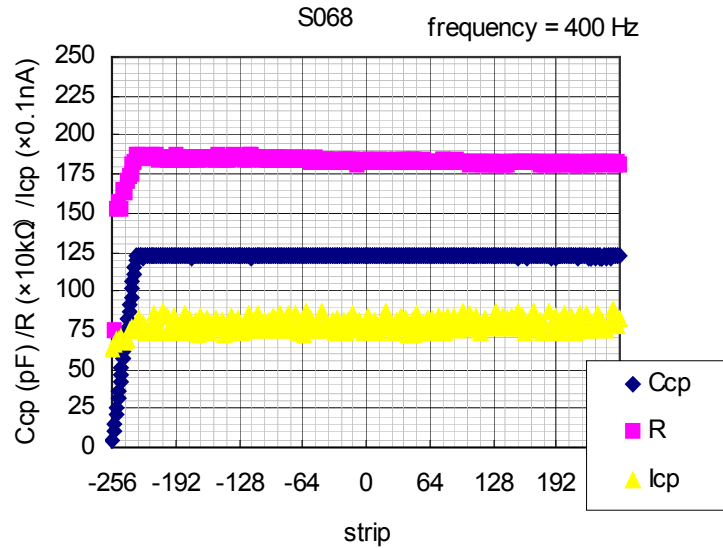
Fig. 4a Example of AC scan result (Stereo #068).

An example is shown in Fig. 4a, where the AC scan results are shown for stereo #068. Nominal values are about 120 pF (coupling capacitance), 1.85 MΩ (series resistance), and 7.5 nA (leakage) for strips with full length. As shown in the figure, coupling capacitance and R are smaller for shorter strips. Note that the 1st data point of R is small due to the frequency setting (1 kHz) is not at the optimum. Most part of the measured leakage is actually through relays used in the measurement system. The leakage through oxide layer is much smaller, and the protection resistors determine the leakage to ~9μA if the oxide is completely punch-through.

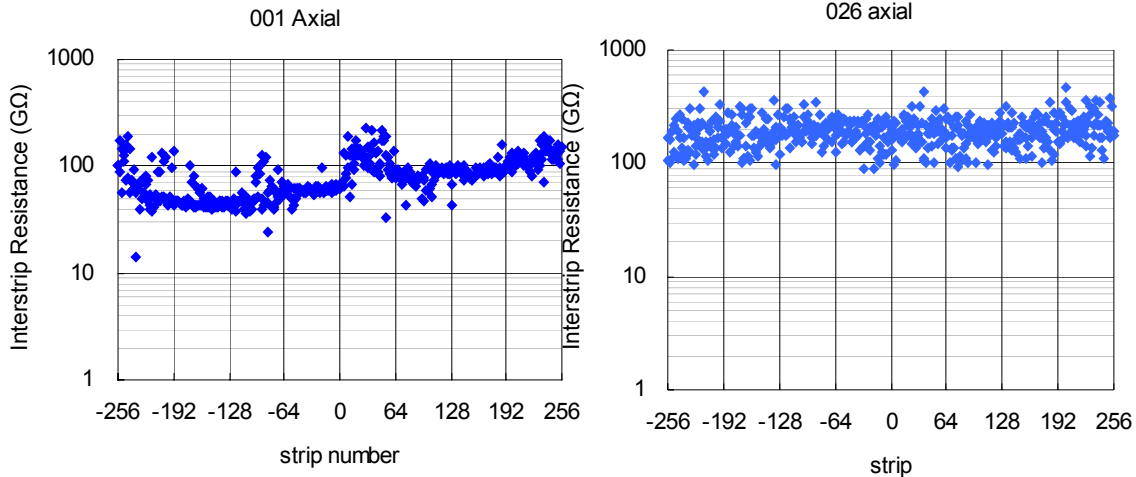
The interstrip resistance is evaluated by measuring the increase/decrease in the strip leakage current when DC voltages ($\pm 1, \pm 0.5 \text{ V}$) are applied to the intermediate strips at neighbor. The four resistance values so obtained are averaged to represent the interstrip resistance. Two examples are shown in Fig. 6. Although the characteristics are different for these sensors, the averages are 50-200 $\text{G}\Omega$ and no strip is smaller than 1 $\text{G}\Omega$, which is our specification. Another sample (Axial 016) showed a distribution very similar to 026 Sensor. We suspect that 001, which was measured right after the delivery (i.e. production), is exceptional, and usual sensors should look like 026 Sensor after the surface charge is stabilized. Unfortunately 001 can not be re-measured since it is used for irradiation with neutrons.

Fig. 6 Interstrip resistance of (left) 001 axial and (right) axial 026 Sensors.

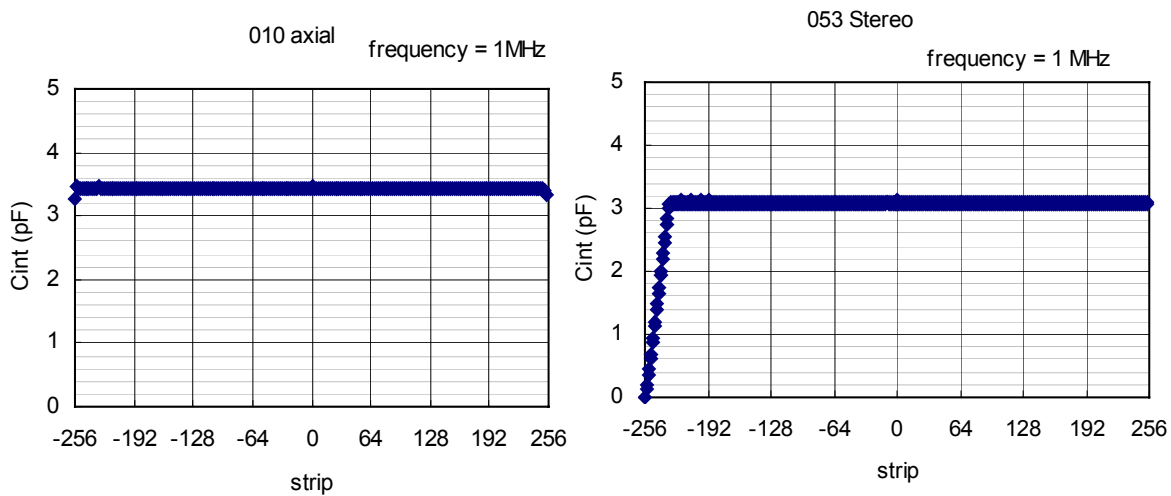
Fig. 7a Interstrip capacitance for (left) axial 010 Sensor and (right) Stereo 053 Sensor.

The interstrip capacitance is measured by probing neighboring (readout) AC pads with other strip at floating. The bias is set to 200 V and the LCR frequency at 1 MHz. The interstrip capacitance is uniform representing the strip length (See Fig 7a). Note that the absolute value difference of 0.3 pF should be the limit in the absolute calibration of our system.

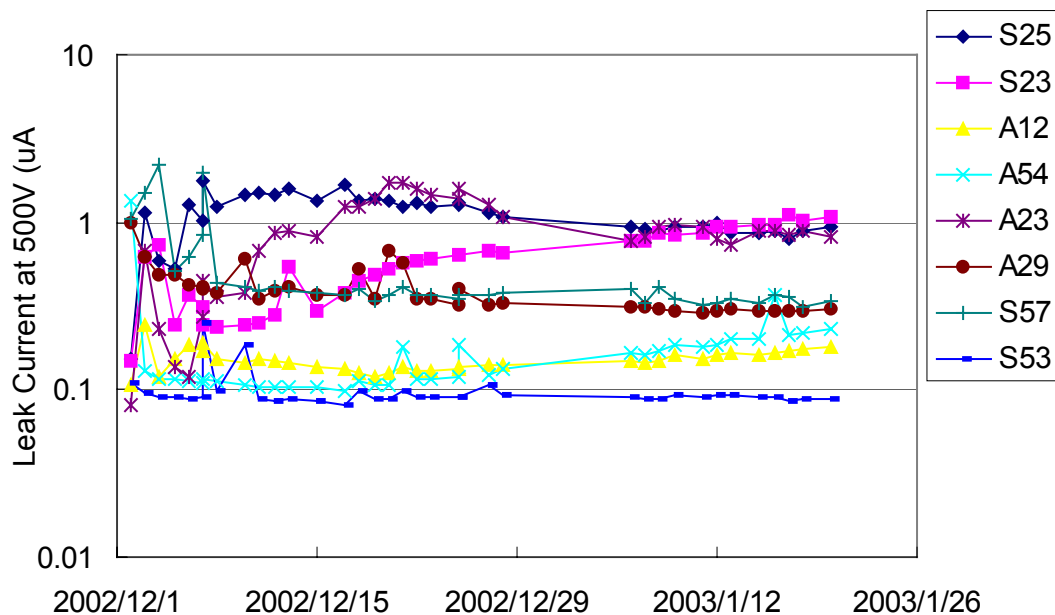
The stability of leakage current is tested for in total eight sensors (4 axial and 4 stereo sensors) for a longer term. The bias voltage is kept at 500 V and the whole setup is placed in an environment chamber at 20°C. The leakage current data are taken typically once per day (the measurement is still on going). In addition to this, the durability of AC oxide is tested: 30 AC pads per sensor are wire bonded to an external voltage of +100V while the bias-ring is set to the ground level. It turns out the leakage current increases substantially when this external 100V is applied because of micro-discharge underneath the extended Al electrodes. Therefore, we decided to turn off this voltage for 1 hr prior to the leakage current measurement. The leakage current since Dec 4 when this decision was made is almost stable.

Out of eight sensors, one axial sensor (A23) showed breakdown at the AC oxide, indicating a creation of punch-through, on the 2nd day. Note again that axial sensors had been tested only at 100V prior. Other seven sensors are good so far.

Fig. 8a Long-term stability test of leakage current. The temperature is 20°C and the bias is 500V. Note the change in the measurement procedure (see text) after 2002/12/05.

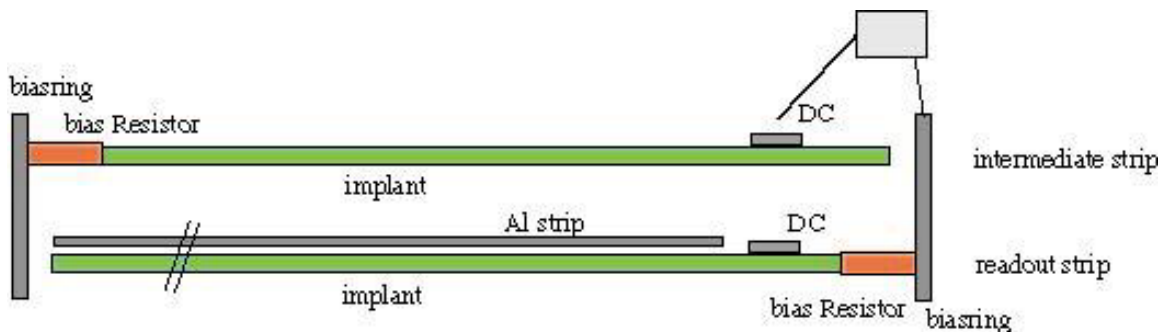
We have detected five implant opens that were not detected by HPK. These are all readout strips. A possible explanation is sketched in Fig. 9. HPK carries out two kinds of tests; DC and AC tests. In the AC test, HPK injects a step pulse on the AC pad and measures the transient signal shape to detect oxide punch-through (evaluate coupling capacitance) and Aluminum strip break/bridge. This procedure is reliable and has been used for many years. In the DC test, HPK applies a DC voltage between the DC pad and bias-ring, and measures the current. This is most sensitive for poly-silicon resistance but also can provide information for the implant open and strip isolation. Since the intermediate strip implant is connected to the bias resistor at far end, the measurement is sensitive to any break in the implant. On the contrary, the system is not sensitive for the readout strip since the implant is connected to the ground at the probing end. Since we do not request DC pads on other end to avoid openings where hybrids are glued, it is not possible to enhance the sensitivity for readout strips. HPK is expecting opens locating near end should also be detected for readout strips. The three opens detected by Tsukuba are located about 2 cm, 7cm and 8 cm from the probing end¹. We have to conclude that the HPK measurement is barely sensitive for detecting readout implant opens.

Fig. 9 Illustration of measurement configurations of readout and intermediate implant opens.
