Characteristics of Prototype Silicon Sensors for Run2b (I)

K. Hara and Y. Takei

University of Tsukuba, Tsukuba, Ibaraki, Japan

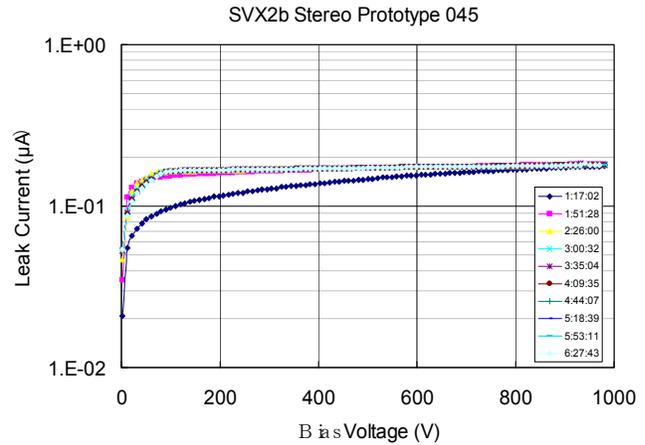
The I-V measurement was repeated 20-30 times (10 times for some sensors) for sampled sensors. All the sensors which showed micro-discharges were tested. Between the I-V measurements, the sensors are biased to 200V and kept for 30 minutes. Figure 2a overlays I-V curves measured for a typical sensor, stereo #045. The curves are consistent and stable although the initial I-V tends to be somewhat different. This may be attributed to that the sensor surface condition has stabilized in time between.

Fig. 2a Typical I-V stability of sensor S045 (stereo).

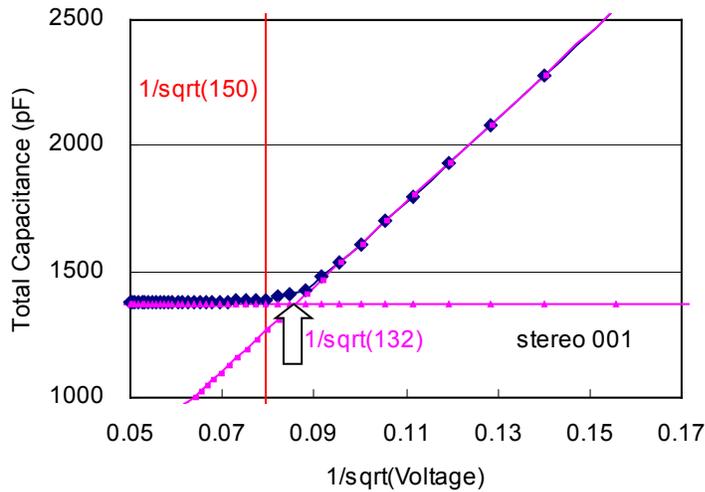
Fig. 3a C-V curve and evaluation of “the full depletion voltage”. HPK determines (see text) it to be 150V, whereas we obtain 132V for this sensor, stereo #001.

The C-V curves are measured for 19 axial and 53 stereo sensors at an LCR frequency of 400 Hz. We extract the full depletion voltage as the intercept of two straight lines in a $C-V^{1/2}$ plot (see Fig. 3a). HPK measures C-V at a voltage step of 10V. The data is used to evaluate the “full depletion voltage”, which is defined to be the lowest voltage where the increase of $1/C^2$ is found to be less than 2%. There is a tendency that HPK gives somewhat larger voltage, as can be seen in Fig. 3b. The distributions of Tsukuba data (axial and stereo separately) and of HPK are given in Fig. 3c. The spread of the distributions are similar, indicating that the full depletion voltages are extracted consistently apart from the

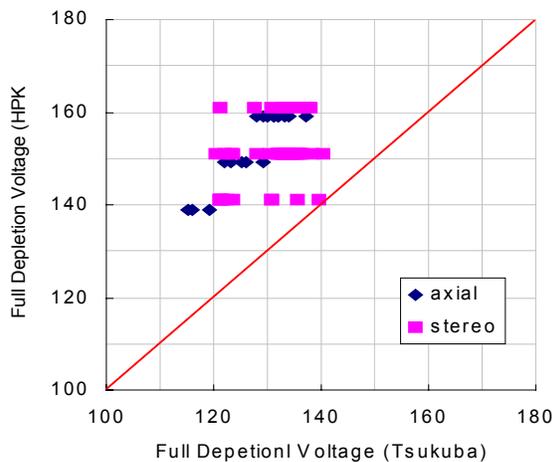
absolute value. As a matter of fact, the value 2% is an arbitral choice so that no fitting is necessarily performed. For a choice of 4%, the agreement between the two should be improved. Three sensors have failed in the full depletion voltage specification, but all of them are more than 115V.

Fig. 3b Correlation of full depletion voltages defined by HPK and Tsukuba.

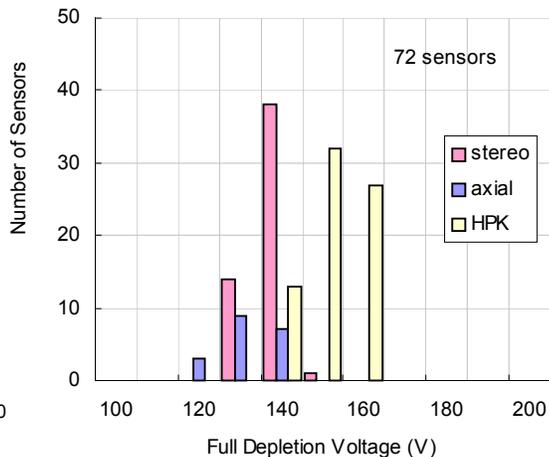
Fig. 3c Full depletion voltage distributions for axial and stereo sensors (Tsukuba) and for all (HPK).

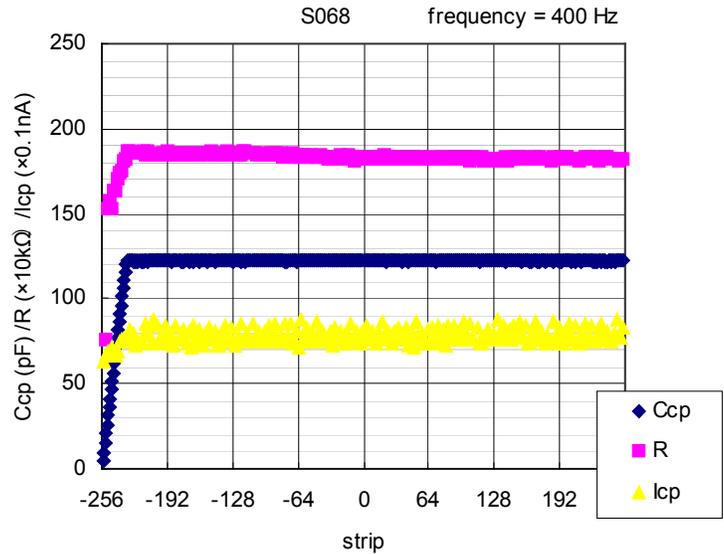
An example is shown in Fig. 4a, where the AC scan results are shown for stereo S068. Nominal values are about 120 pF (Ccp: coupling capacitance), 1.85 MΩ (R: series resistance), and less than 10 nA (Icp: leakage) for the strips with full length. As shown in the figure, coupling capacitance and R are smaller for shorter strips. Note that the 1st data point of R is small due to the frequency setting (1 kHz) is not at the optimum. Most part of the measured leakage Icp is actually through relays used in the measurement system. The leakage through genuine oxide layer is much smaller. If the oxide is completely punch-through, protection resistors in the system determine the leakage to ~9μA.

Fig. 4a Example of AC scan result (Stereo S068).

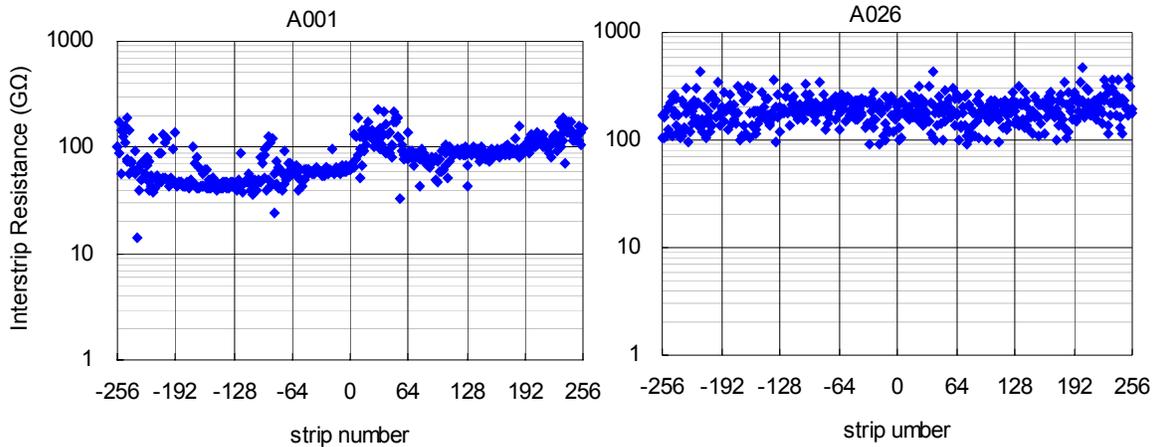
The interstrip resistance is evaluated by measuring the increase/decrease in the strip leakage current when DC voltages ($\pm 1, \pm 0.5 \text{ V}$) are applied to the intermediate strips at neighbor. The four resistance values so obtained are averaged to represent the interstrip resistance. Three axial sensors have been measured. Two distributions are shown in Fig. 6. Although the characteristics look different, the averages are 50-200 $\text{G}\Omega$ and no strip is smaller than $1 \text{ G}\Omega$, our specification. Another sample (Axial A016) showed a distribution very similar to A026 Sensor. A001 was measured right after the delivery (i.e. production) and other two were measured about one month later. The difference could be instrumental, but we suspect that A001 is exceptional “remembering” the process conditions and usual sensors should look like S026 after conditioned. Unfortunately this hypothesis can not be checked, since A001 is irradiated with neutrons.

Fig. 6 Interstrip resistance of (left) A001 and (right) A026 Sensors.

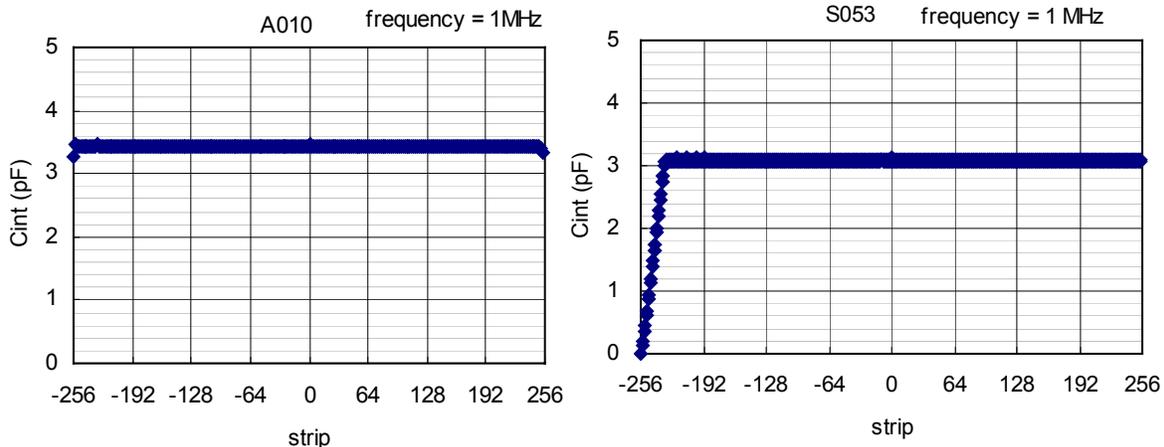
The interstrip capacitance is measured by probing neighboring (readout) AC pads with other strip at floating. The bias is set to 200 V and the LCR frequency at 1 MHz. The interstrip capacitance is quite uniform representing the strip length (See Fig 7a). Note that the absolute values are different by 0.3 pF, which should be attributed to the calibration accuracy of our system.

Fig. 7a Interstrip capacitance for (left) axial 010 Sensor and (right) Stereo 053 Sensor.

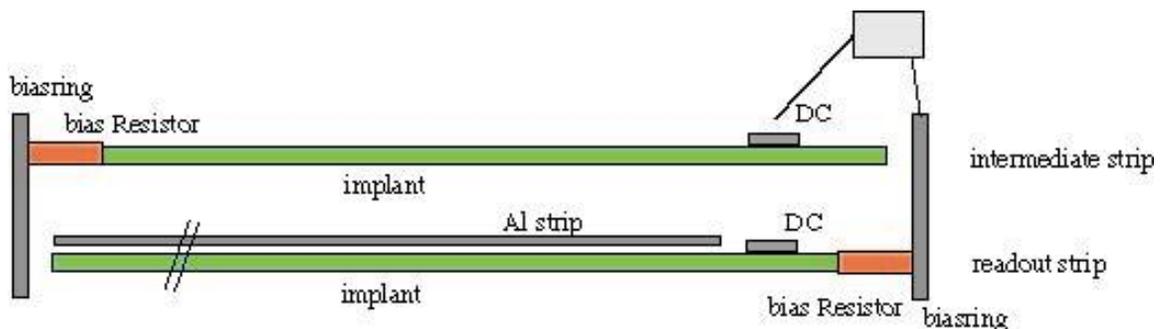
We have detected five implant opens that were not detected by HPK. These are all readout strips. A possible explanation is sketched in Fig. 9. HPK carries out two kinds of tests, DC and AC tests. In the AC test, HPK injects a step pulse on the AC pad and measures the transient signal shape to detect oxide punch-through (evaluate coupling capacitance) and aluminum strip break/bridge. This procedure is reliable and has been used for many years. In the DC test, HPK applies a DC voltage between the DC pad and bias-ring, and measures the current. This is most sensitive for poly-silicon resistance but also can provide information for the implant open and strip isolation. Since the intermediate strip implant is connected to the bias resistor at far end, the measurement is sensitive to any break in the implant. On the contrary, the system is not sensitive for the readout strip open since the implant is connected to the ground at the probing end. Since we do not request DC pads on other end to avoid openings where hybrids are glued, it is not possible to enhance the sensitivity for readout strip opens. HPK is expecting the AC scan has some sensitivity for the opens locating the near end. The five opens detected by Tsukuba locate about 2 cm, 3 cm, 7cm, 7cm and 8 cm from the probing end¹. We have to conclude that the HPK measurement is barely sensitive for detecting readout implant opens.

Fig. 9 Illustration of measurement configurations of readout and intermediate implant opens.

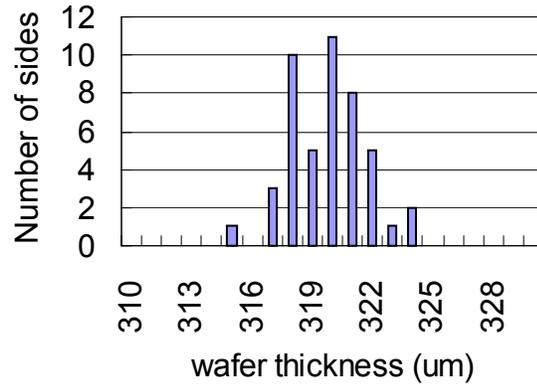
The wafer thickness was measured for 24 sensors at the center of shorter sides. The sensors were placed vertically on the stage under the microscope. The distribution of 48 measurement results is shown in Fig. 10a. The central value is 320 μm with a spread of about 5 μm . Since we used wafers of the same lot, the spread may become wider at production. The precision quoted by HPK is 15 μm .

Fig. 10a Wafer thickness distribution

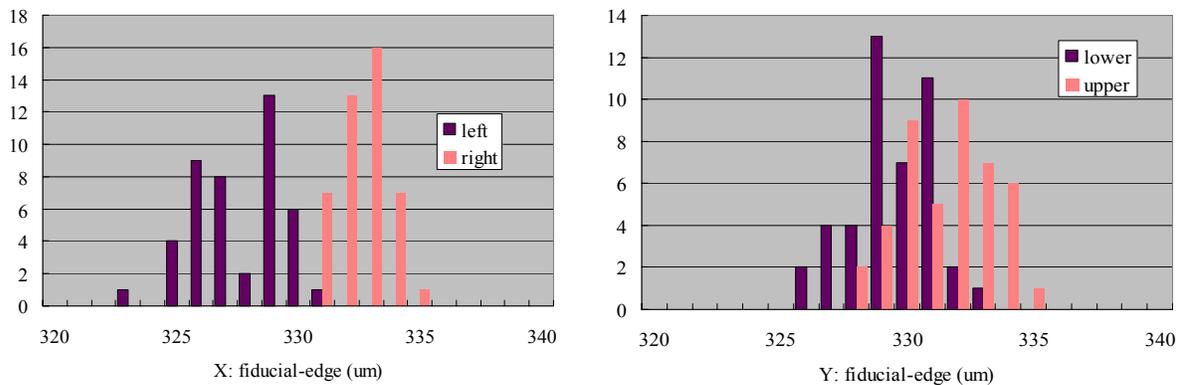
The distance between the fiducial mark to the edge was measured at the four corners. The nominal distance is 330 μm . Although no systematic difference between axial and stereo sensors was seen, there are some systematic deviations among the different sides. The right side (shorter hybrid side) tends to be wider than the nominal distance while the left side (shorter probing side) tends to be narrower. Such a difference is smaller for the longer sides. The edge cutting for the present samples is precise to 5 μm , although the quoted precision is 20 μm .

Fig. 10b Distance between the fiducial to the edge.

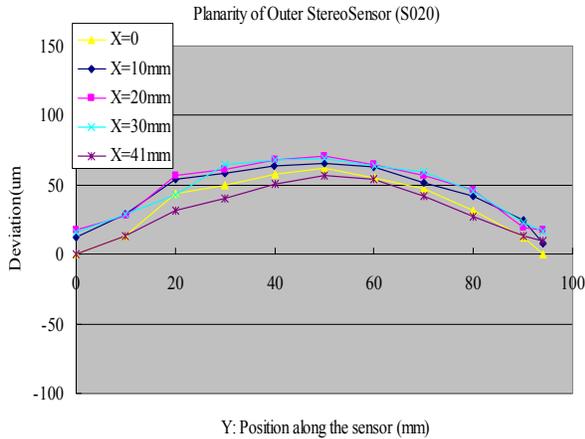
The general profile is measured on 1 cm grids with a laser system at first. Typical results are given in Fig. 10c, where the three corner data are used to define the reference plane and the deviations to it are plotted. The positive deviations mean that the sensor is bowed with the strip on convex side. The profile is generally universal among the different sensors.

Fig. 10c Typical Z profile of a stereo sensor

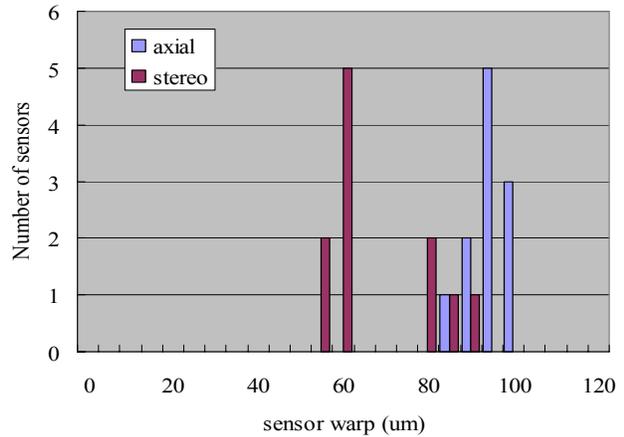
In order to increase the statistics, the height at the sensor center was measured with a microscope together with the heights at the fiducials when the edge cut precision data were taken. The height relative to the fiducial heights is histogrammed in Fig. 10d. The warp is typically 80 to 100 μm for axial sensors, while it is 55 to 90 μm for stereo sensors. The difference could be qualitatively explained by that the stereo sensors are wider than axial sensors.

Fig. 10d The deviation in Z at the sensor center
